Asbestos Management Survey

5 Verster street Paarl 7646

Surveyed On: 3 Dec 2021

Report By	Asbestos Consulting
Client	Cafe Sophia
Project	Asbestos identification
Site Address	5 Verster street Paarl 7646
Site Coordinates	-33.7298482, 18.9667395
Site Location

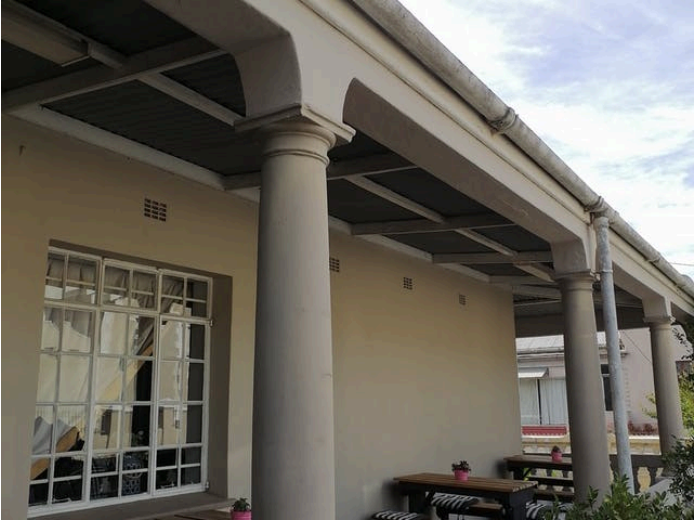
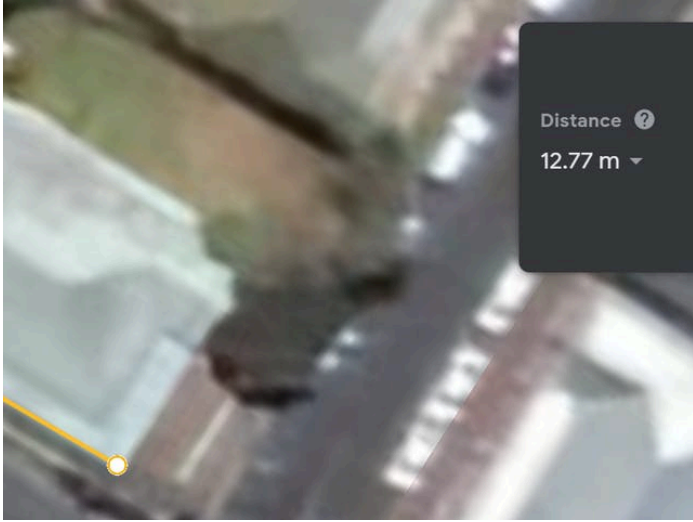
001 -WESTERN SIDE > > 001 - Gutter >

Strategy / Sample Id	Strongly Presume	Presumed Fibre Type	Chrysotile
Recommendation	Mark and manage		
General Comments	The gutters are in a good condition and must be inspected and cleaned at least 3 times a year

Product Type (or Debris from Product)	1	Extent of Damage / Deterioration	1
Surface Type / Treatment	0	Asbestos Type	1
Material Score	3 / Very Low

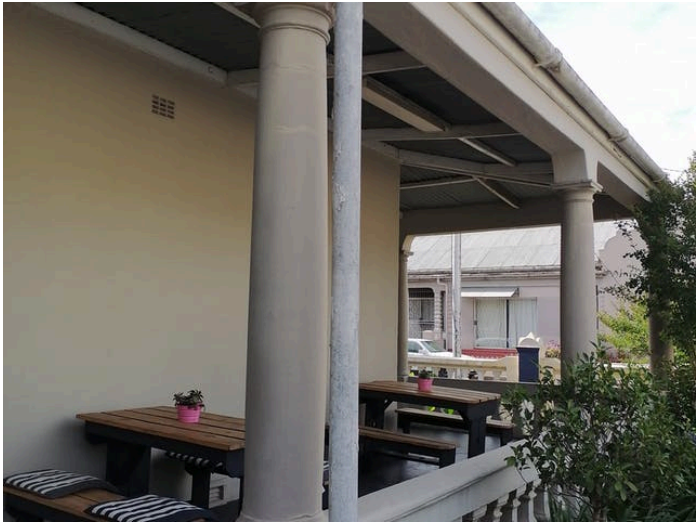
002 -WESTERN SIDE > > 002 - downpipe >

Strategy / Sample Id	Sample / 001	Fibre Type	Chrysotile
Recommendation	Mark and manage		
General Comments	Down pipes are in a good condition and painted. Regular maintenance is required

Product Type (or Debris from Product)	1	Extent of Damage / Deterioration	1
Surface Type / Treatment	0	Asbestos Type	1
Material Score	3 / Very Low

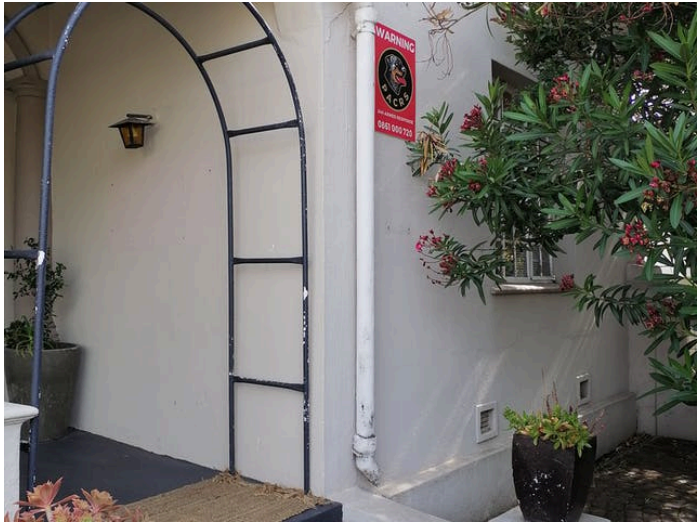
003 - SOUTHERN SIDE > > 004 - downpipe > 200mm down pipe

Strategy / Sample Id	Sample / 002	Fibre Type	Chrysotile
Recommendation	Mark and manage		
General Comments	Downpipe is in a good condition. Regular maintenance is required

Product Type (or Debris from Product)	1	Extent of Damage / Deterioration	1
Surface Type / Treatment	0	Asbestos Type	1
Material Score	3 / Very Low

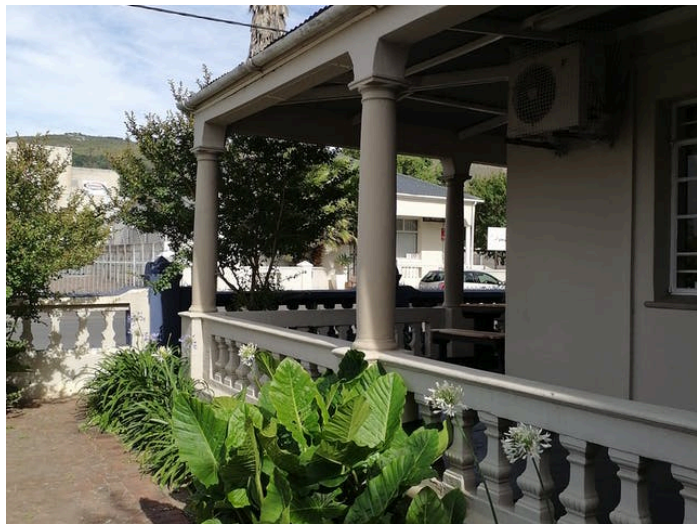
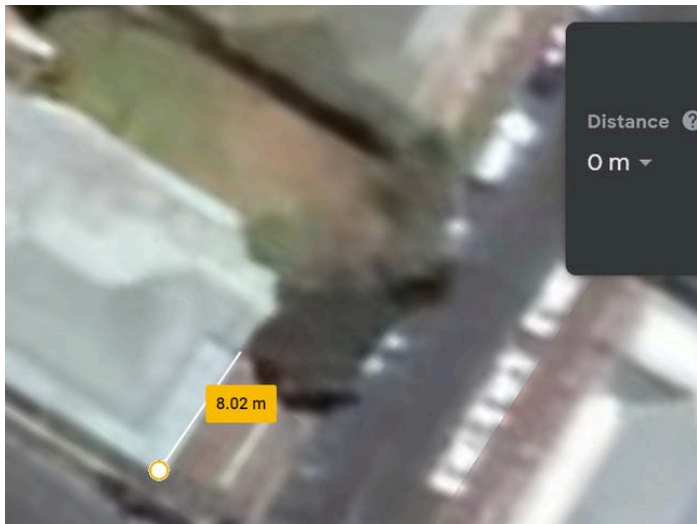
004 - SOUTHERN SIDE > > 004 - Gutter >

General Comments	Gutters are in a good condition. Regular maintenance is required, at least 3 times a year the gutters must be cleaned.

Product Type (or Debris from Product)	1	Extent of Damage / Deterioration	1
Surface Type / Treatment	0	Asbestos Type	1
Material Score	3 / Very Low

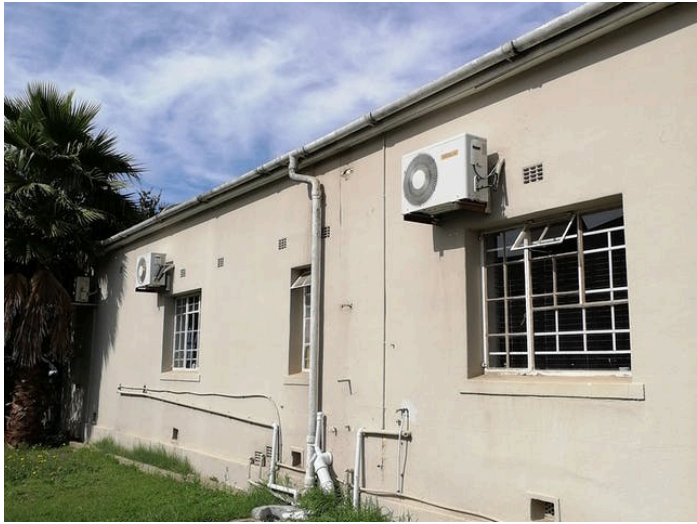
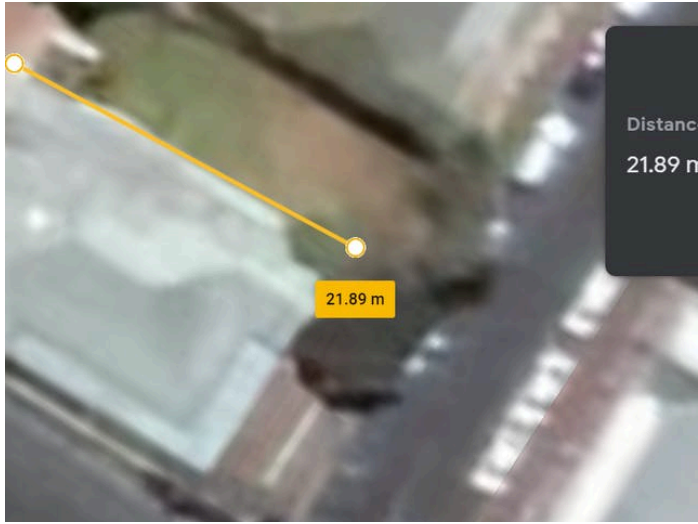
005 - EASTERN SIDE > > 006 - gutter > D Shape gutters

Strategy / Sample Id	Strongly Presume	Presumed Fibre Type	Chrysotile
Recommendation	Mark and manage		
General Comments	The gutter is in good condition. Regular maintenance is required

Product Type (or Debris from Product)	1	Extent of Damage / Deterioration	1
Surface Type / Treatment	0	Asbestos Type	1
Material Score	3 / Very Low

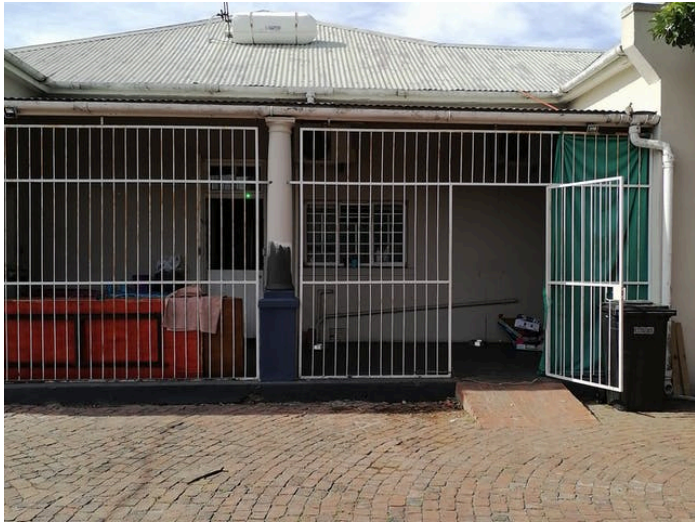
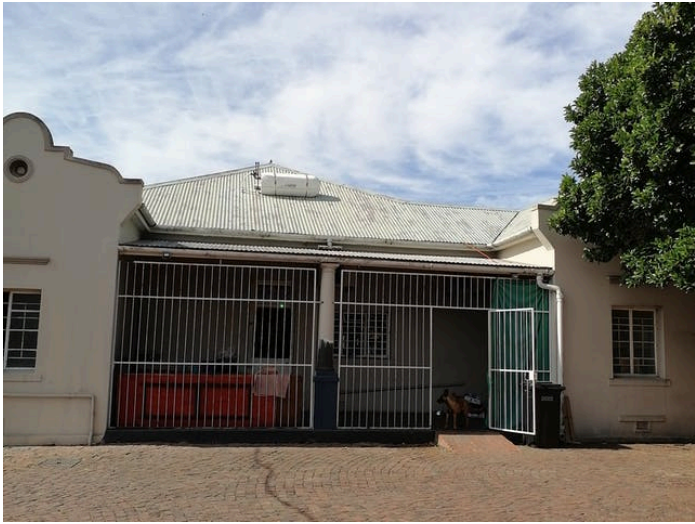
006 - NORTHERN SIDE > > 004 - gutter > D Shape gutters

Strategy / Sample Id	Strongly Presume	Presumed Fibre Type	Chrysotile
Recommendation	Mark and manage		
General Comments	The gutter is a good condition. Cleaning is required at least 3 times a year

Product Type (or Debris from Product)	1	Extent of Damage / Deterioration	1
Surface Type / Treatment	0	Asbestos Type	1
Material Score	3 / Very Low

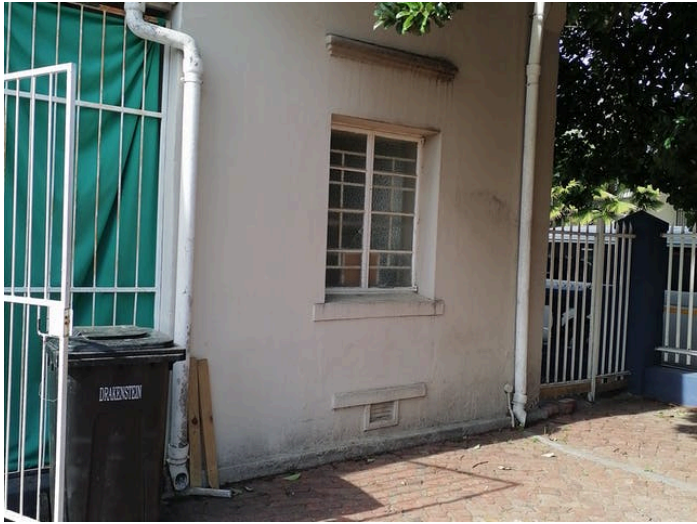
007- NORTHERN SIDE > > 007- Downpipes >

Strategy / Sample Id	Sample / 003	Fibre Type	Chrysotile
Recommendation	Mark and manage		
General Comments	The downpipes is in good condition. Regular maintenance is required

Product Type (or Debris from Product)	1	Extent of Damage / Deterioration	1
Surface Type / Treatment	0	Asbestos Type	1
Material Score	3 / Very Low

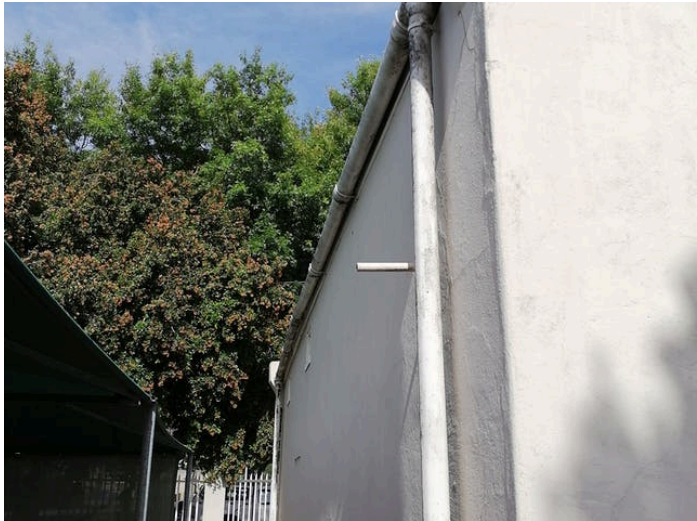
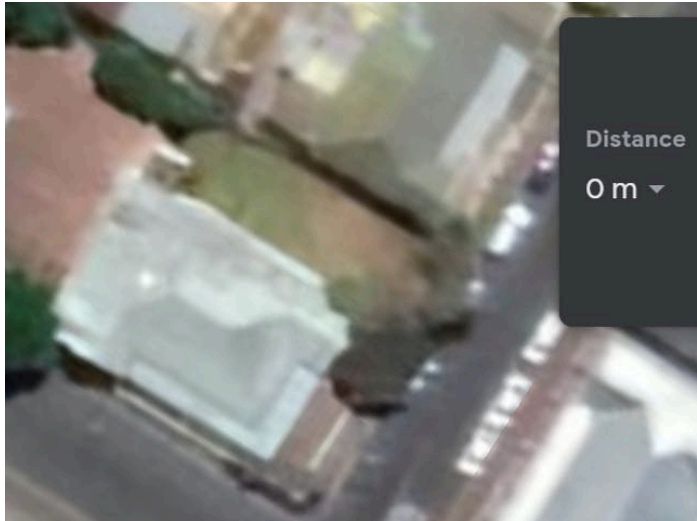
008 -OUTSIDE BUILDING > > 008 - gutter > D Shape gutters

Strategy / Sample Id	Strongly Presume	Presumed Fibre Type	Chrysotile
Recommendation	Mark and manage		
General Comments	The gutters on both sides are in good condition. Please make sure that the gutters are cleaned and maintained on a regular basis.

Product Type (or Debris from Product)	1	Extent of Damage / Deterioration	1
Surface Type / Treatment	0	Asbestos Type	1
Material Score	3 / Very Low

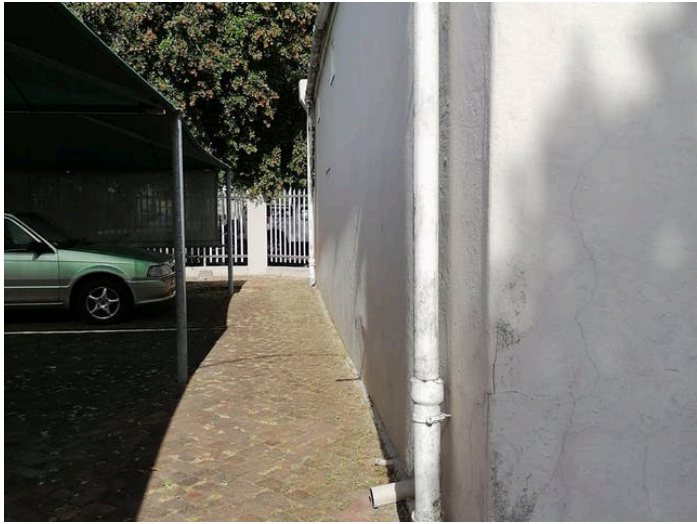
009 -OUTSIDE BUILDING > > 009 - downpipe > 125 mm downpipe

Strategy / Sample Id	Strongly Presume	Presumed Fibre Type	Chrysotile
Recommendation	Mark and manage		
General Comments	The downpipes are in good condition. Regular maintenance is required to prevent breakages

Product Type (or Debris from Product)	1	Extent of Damage / Deterioration	1
Surface Type / Treatment	0	Asbestos Type	1
Material Score	3 / Very Low

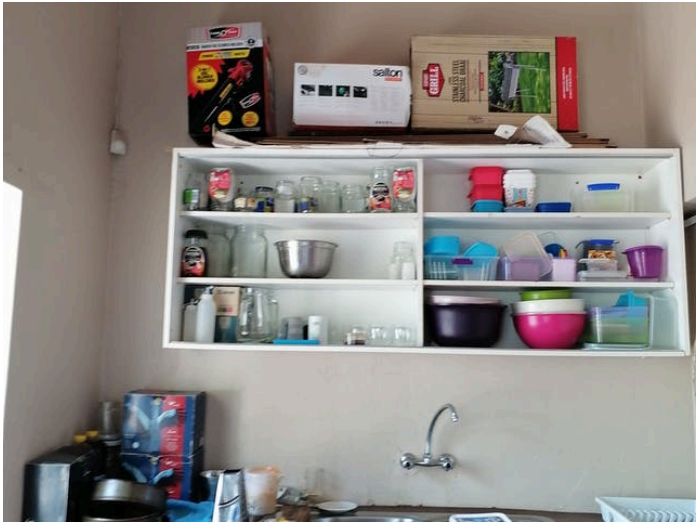
010 - INSIDE > > 010 - Kitchen wash area > Ceiling

Strategy / Sample Id	Presume	Presumed Fibre Type	Chrysotile
Recommendation	Mark and manage		
General Comments	Painted and in good condition. Maintenance is required

Product Type (or Debris from Product)	1	Extent of Damage / Deterioration	0
Surface Type / Treatment	0	Asbestos Type	1
Material Score	2 / Very Low

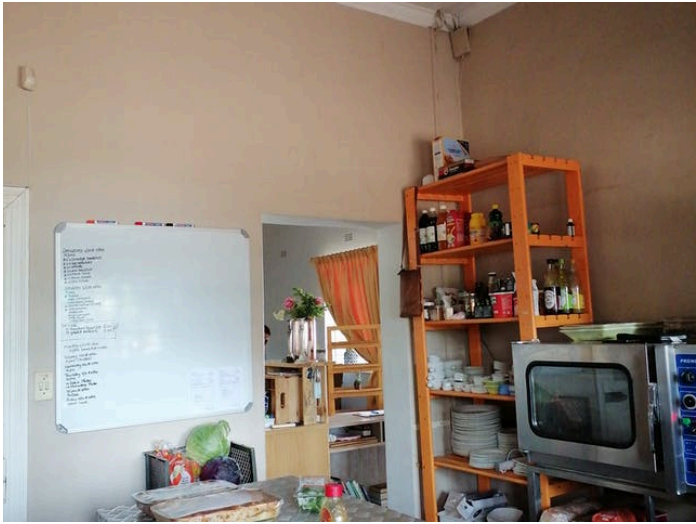
011 - INSIDE > > 011- kitchen > Ceiling

Strategy / Sample Id	Presume	Presumed Fibre Type	Chrysotile
Recommendation	Mark and manage		
General Comments	The ceiling is painted and in good condition. Prevent damage the ceiling

Product Type (or Debris from Product)	1	Extent of Damage / Deterioration	1
Surface Type / Treatment	0	Asbestos Type	1
Material Score	3 / Very Low

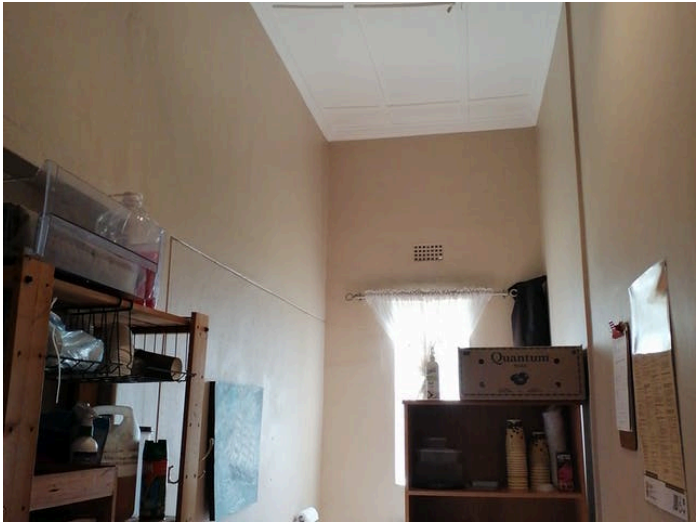
012 - INSIDE > > 012 - Laundry and staff toilet > Ceiling

Strategy / Sample Id	Presume	Presumed Fibre Type	Chrysotile
Recommendation	Mark and manage		
General Comments	The ceilings are in good condition. The area is well managed. Prevent any breakages

Product Type (or Debris from Product)	1	Extent of Damage / Deterioration	1
Surface Type / Treatment	0	Asbestos Type	1
Material Score	3 / Very Low

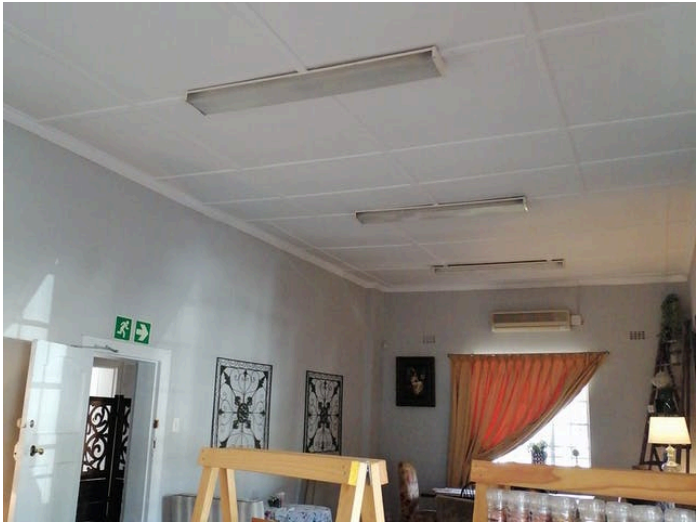
013- INSIDE > > 013- DINNING AREA > Gutters

Strategy / Sample Id	Presume	Presumed Fibre Type	Chrysotile
Recommendation	Mark and manage		
General Comments	The ceiling is a good condition. Prevent damages to the ceiling at all times

Product Type (or Debris from Product)	1	Extent of Damage / Deterioration	0
Surface Type / Treatment	0	Asbestos Type	1
Material Score	2 / Very Low

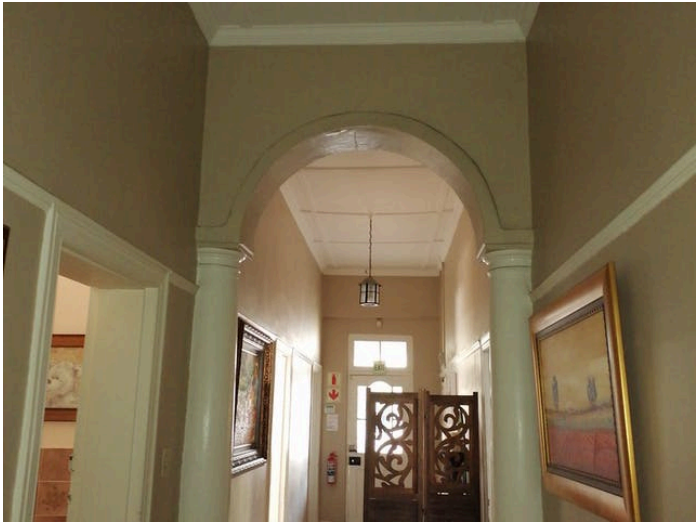
014- INSIDE > > 014 - Hall way > Ceiling

Strategy / Sample Id	Presume	Presumed Fibre Type	Chrysotile
Recommendation	Mark and manage		
General Comments	The ceiling is painted and in good condition. Prevent damages to it at all times

Product Type (or Debris from Product)	1	Extent of Damage / Deterioration	0
Surface Type / Treatment	0	Asbestos Type	1
Material Score	2 / Very Low

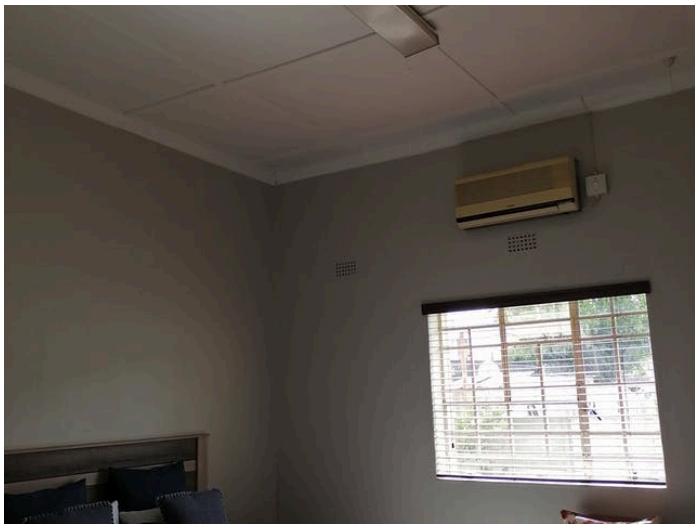
015 - INSIDE > > 015 - Bedroom 1 > Ceiling

Strategy / Sample Id	Presume	Presumed Fibre Type	Chrysotile
Recommendation	36m ²		
General Comments	The ceilings are painted in good condition. Prevent any damages

Product Type (or Debris from Product)	1	Extent of Damage / Deterioration	0
Surface Type / Treatment	0	Asbestos Type	1
Material Score	2 / Very Low

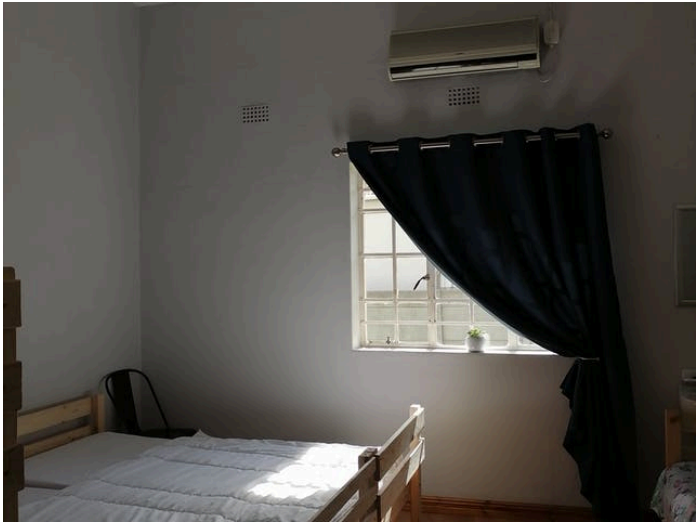
016 - INSIDE > > 016 - bedroom 2 > Ceiling

Strategy / Sample Id	Presume	Presumed Fibre Type	Chrysotile
Recommendation	Mark and manage		
General Comments	The ceiling is painted and in good condition. Prevent any damages

Product Type (or Debris from Product)	1	Extent of Damage / Deterioration	0
Surface Type / Treatment	0	Asbestos Type	1
Material Score	2 / Very Low

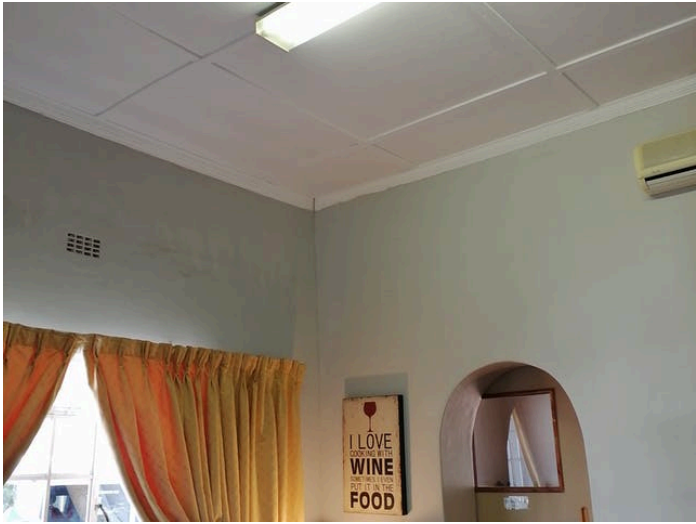
017 - INSIDE > > 07 - Reception > Ceiling

Strategy / Sample Id	Presume	Presumed Fibre Type	Chrysotile
Recommendation	Mark and manage		
General Comments	The ceiling is painted and in good condition. Prevent damages at all cost

Product Type (or Debris from Product)	1	Extent of Damage / Deterioration	0
Surface Type / Treatment	0	Asbestos Type	1
Material Score	2 / Very Low
