# ASBESTOS MANAGEMENT SURVEY

16 Minor road, Franschhoek, 7690

Asbestos identification and inventory

| Client | Franschhoek Hotel & Spa |

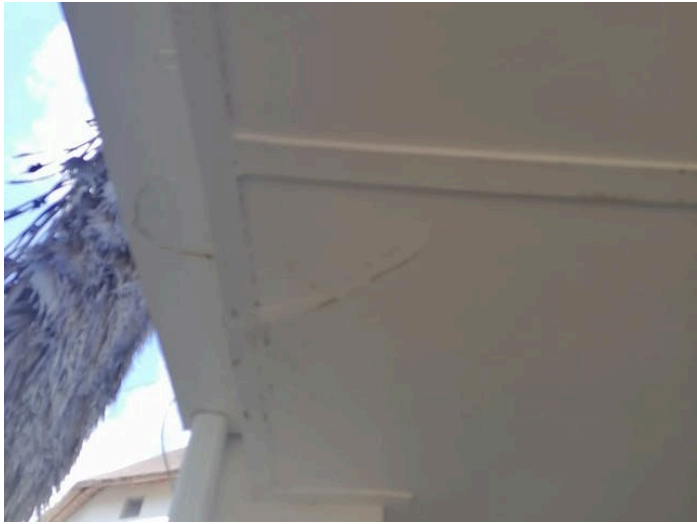
| Location | Walkway ceilings | Item | Ceiling |

| Material | Compressed | Extent | 25m <sup>2</sup> |
| Strategy / Sample Id | Sample / 002 | Fibre Type | Chrysotile |

| Product Type (or Debris from Product) | 1 | Extent of Damage / Deterioration | 1 |

| Recommendation | Mark and manage | | |
| General Comments | Mark ceiling boards and ... ent any breakages or remove and replace | | |

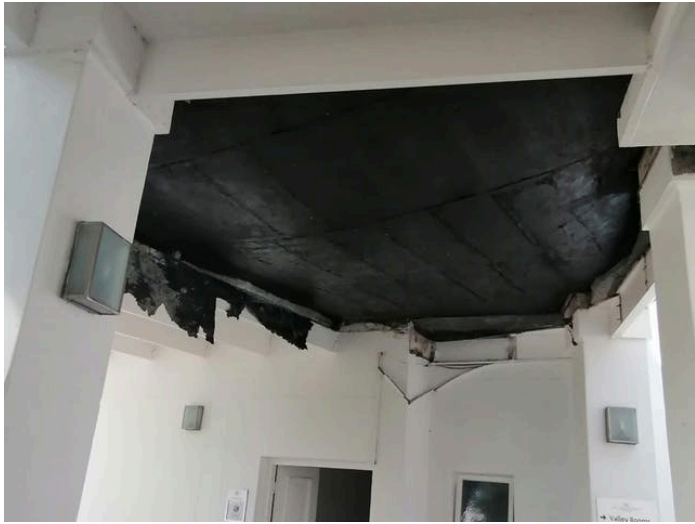
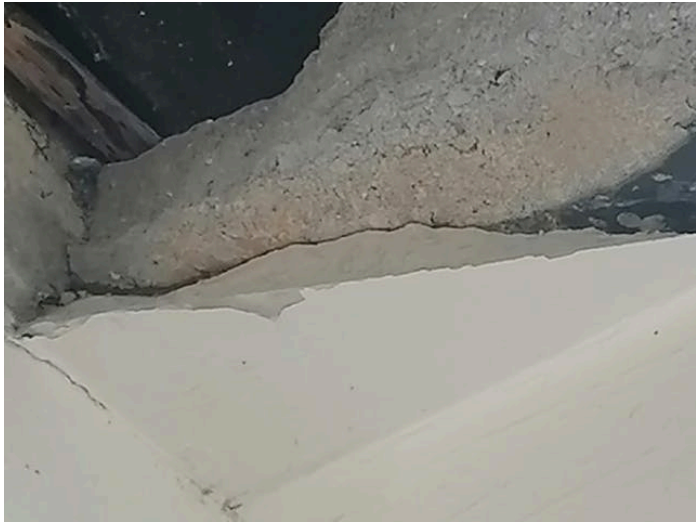
| Location | Walkway collapsed ceiling | Item | Ceiling |

| Material | Compressed | Extent | 8m <sup>2</sup> |
| Strategy / Sample Id | Sample / 001 | Fibre Type | Chrysotile |

| Product Type (or Debris from Product) | 1 | Extent of Damage / Deterioration | 2 |

| Recommendation | Removal by licensed contractor | | |

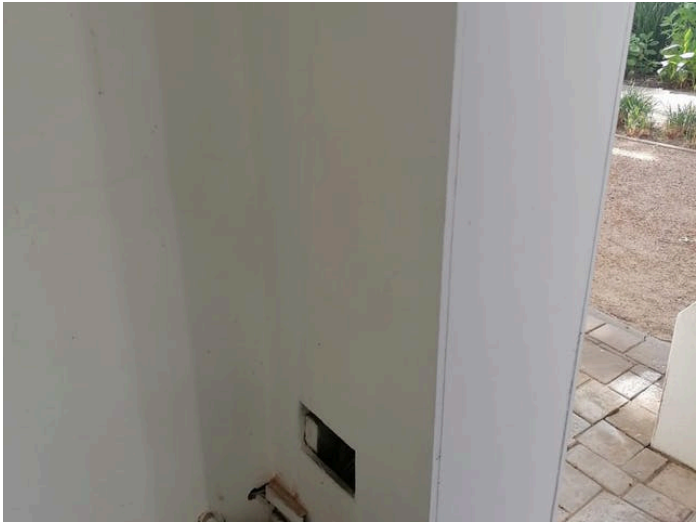
| Location | Walkway columns | Item | Flat sheet |

| Material | Compressed | Extent | 10m <sup>2</sup> |
| Strategy / Sample Id | Sample / 004 | Fibre Type | Chrysotile |

| Product Type (or Debris from Product) | 1 | Extent of Damage / Deterioration | 1 |

| Recommendation | Mark and manage | | |

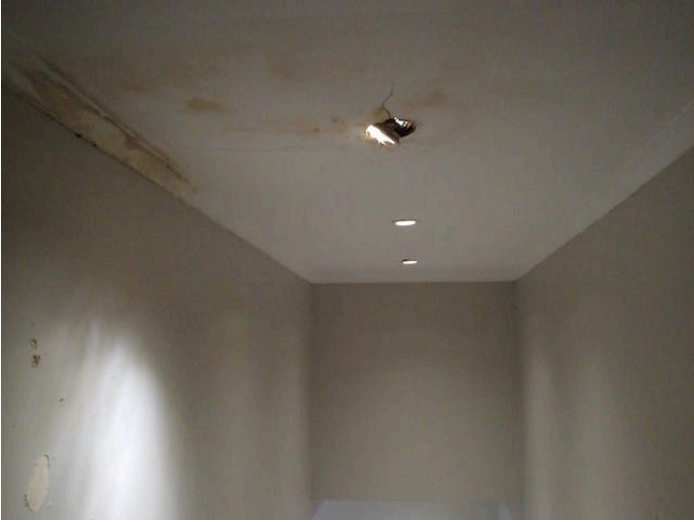
| Location | Kitchen | Item | Ceiling |

| Material | Compressed | Extent | 25m <sup>2</sup> |
| Strategy / Sample Id | Sample / 003 | Fibre Type | Chrysotile |

| Product Type (or Debris from Product) | 1 | Extent of Damage / Deterioration | 1 |

| Recommendation | Mark and manage | | |
| General Comments | Please make sure that no major repairs occur. Paint on a yearly basis. | | |
