# ASBESTOS MANAGEMENT SURVEY

16 Minor road, Franschhoek, 7690

Asbestos identification and inventory

| Client | Franschhoek Hotel & Spa |

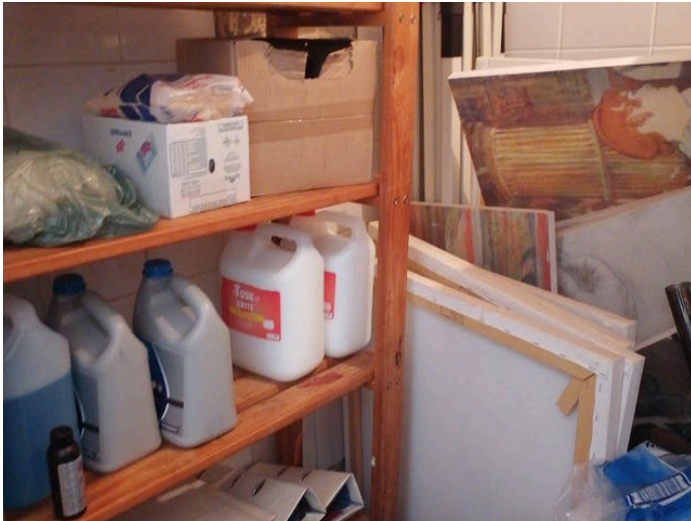
| Location | Ffirst floor store room | Item | No Asbestos |

| Material | No Asbestos Identified | Extent | |

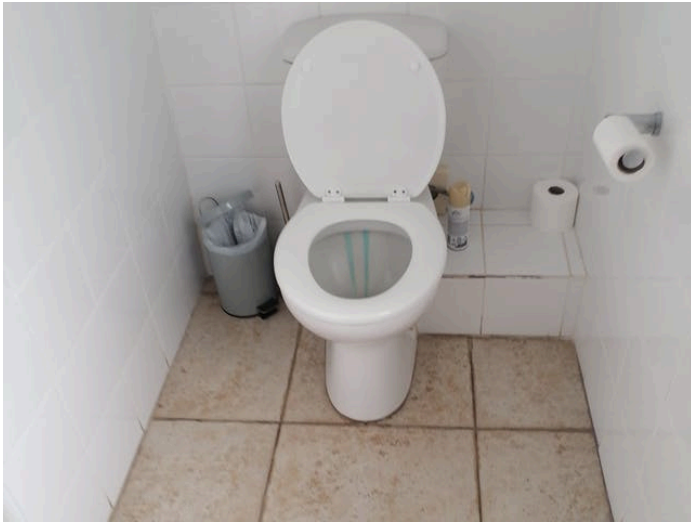
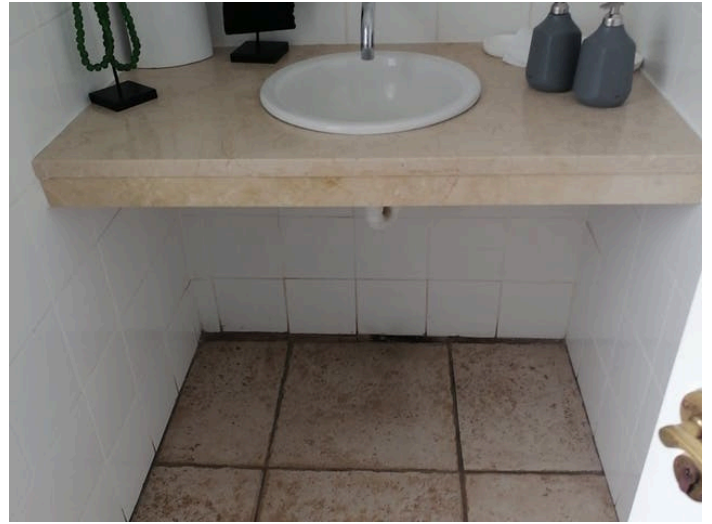
| Location | first floor bathroom | Item | No Asbestos |

| Material | No Asbestos Identified | Extent | |

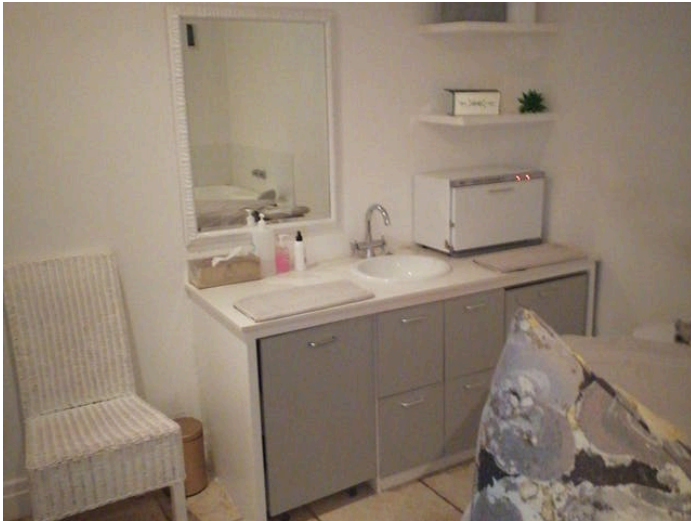
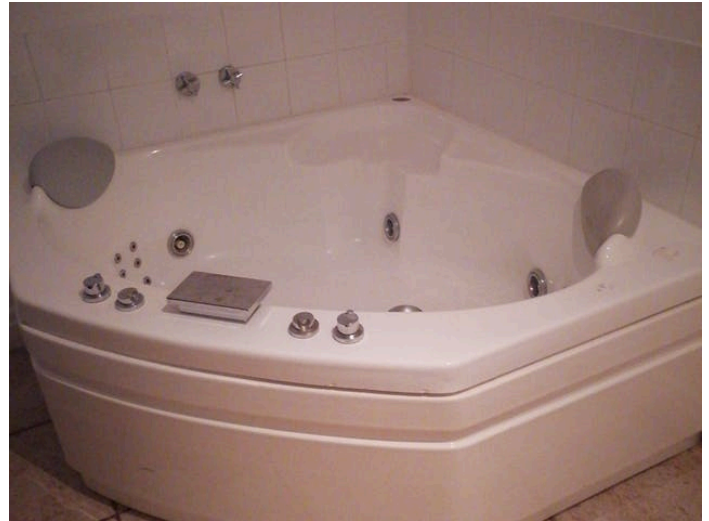
| Location | First floor room 1 | Item | No Asbestos |

| Material | No Asbestos Identified | Extent | |

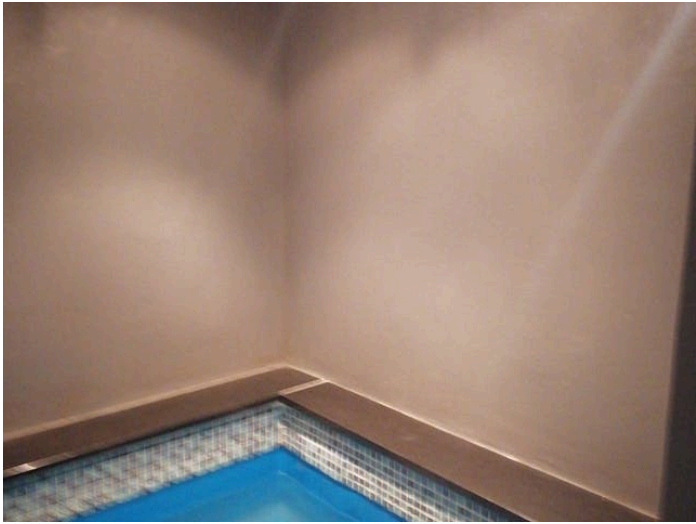
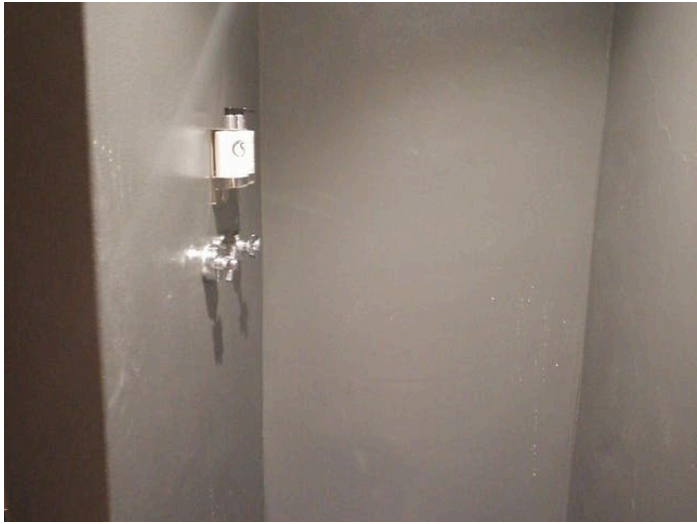
| Location | First floor room 2 | Item | No Asbestos |

| Material | No Asbestos Identified | Extent | |

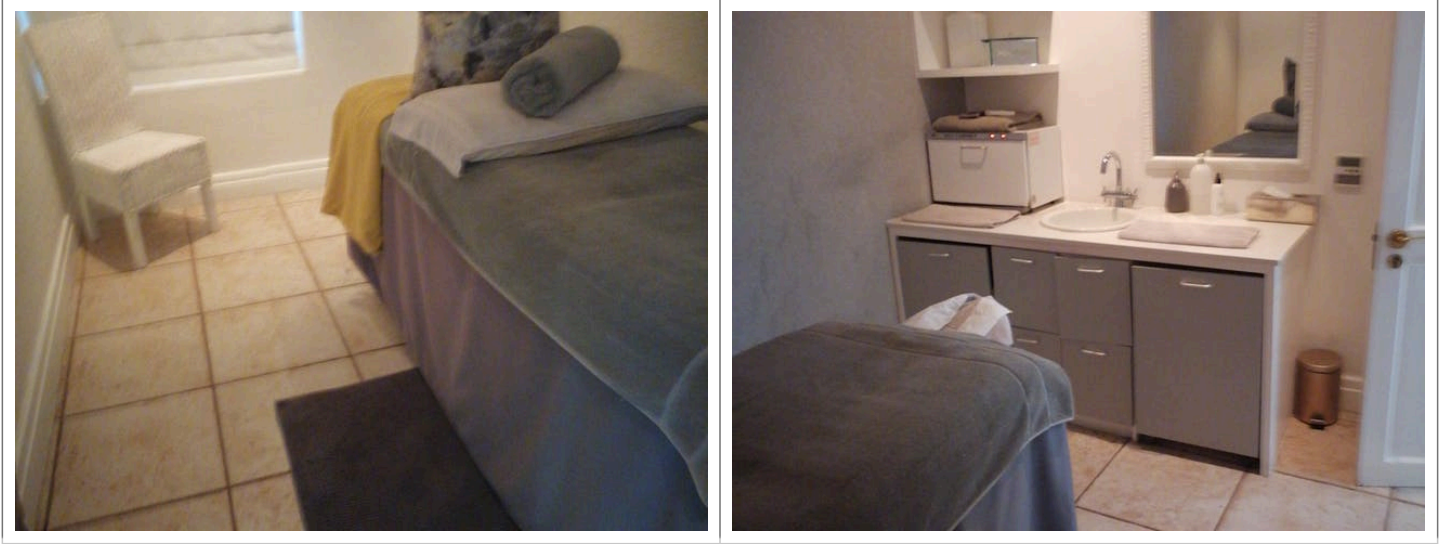
| Location | First floor room 3 | Item | No Asbestos |

| Material | No Asbestos Identified | Extent | |

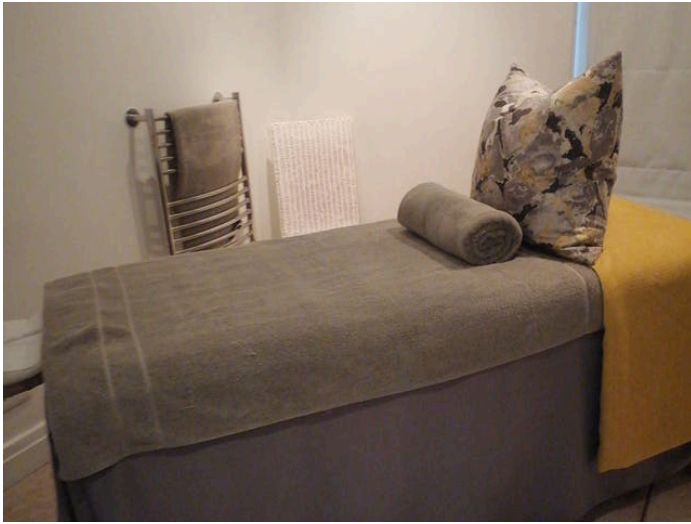
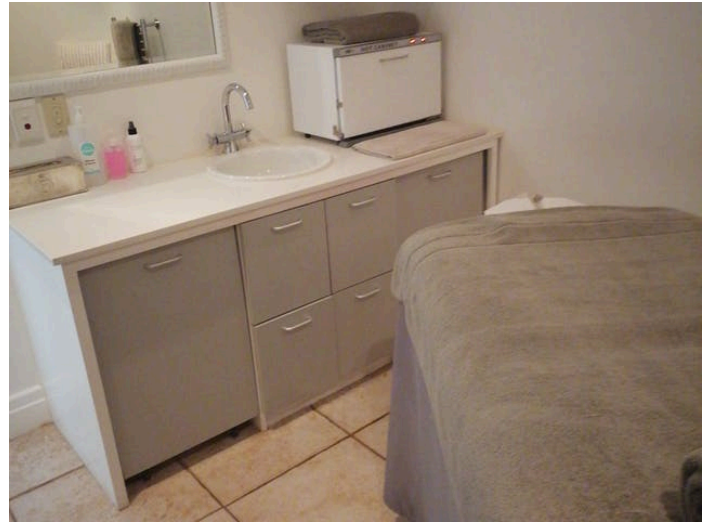
| Location | First floor room 4 | Item | No Asbestos |

| Material | No Asbestos Identified | Extent | |

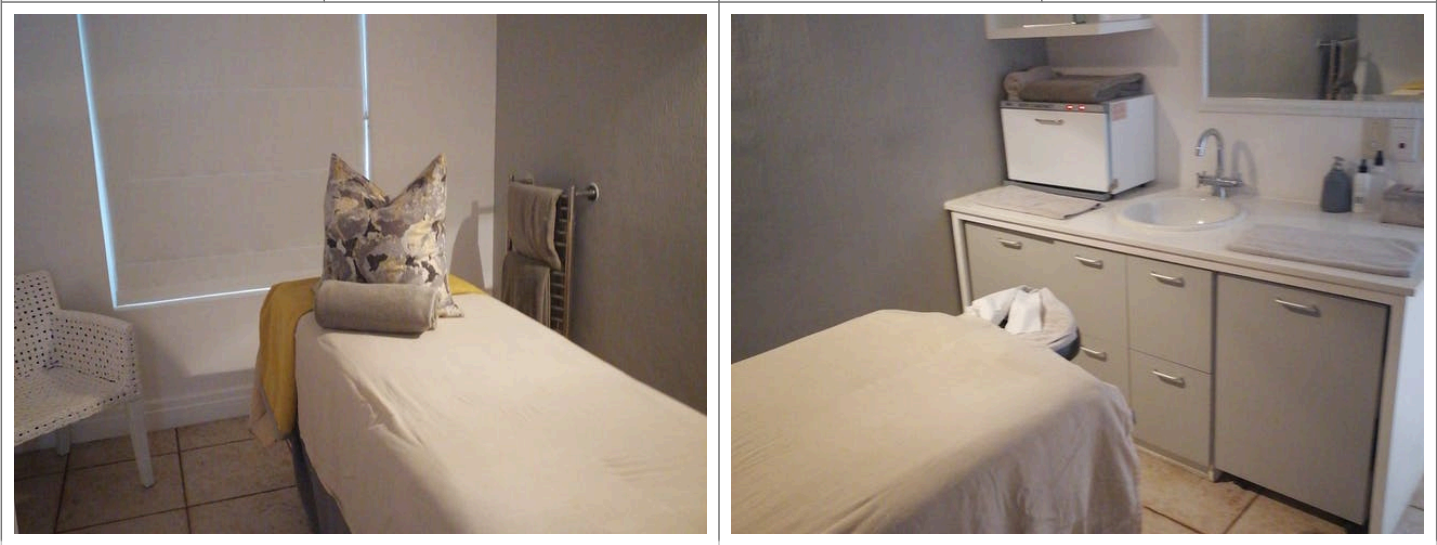
| Location | First floor room 5 | Item | No Asbestos |

| Material | No Asbestos Identified | Extent | |

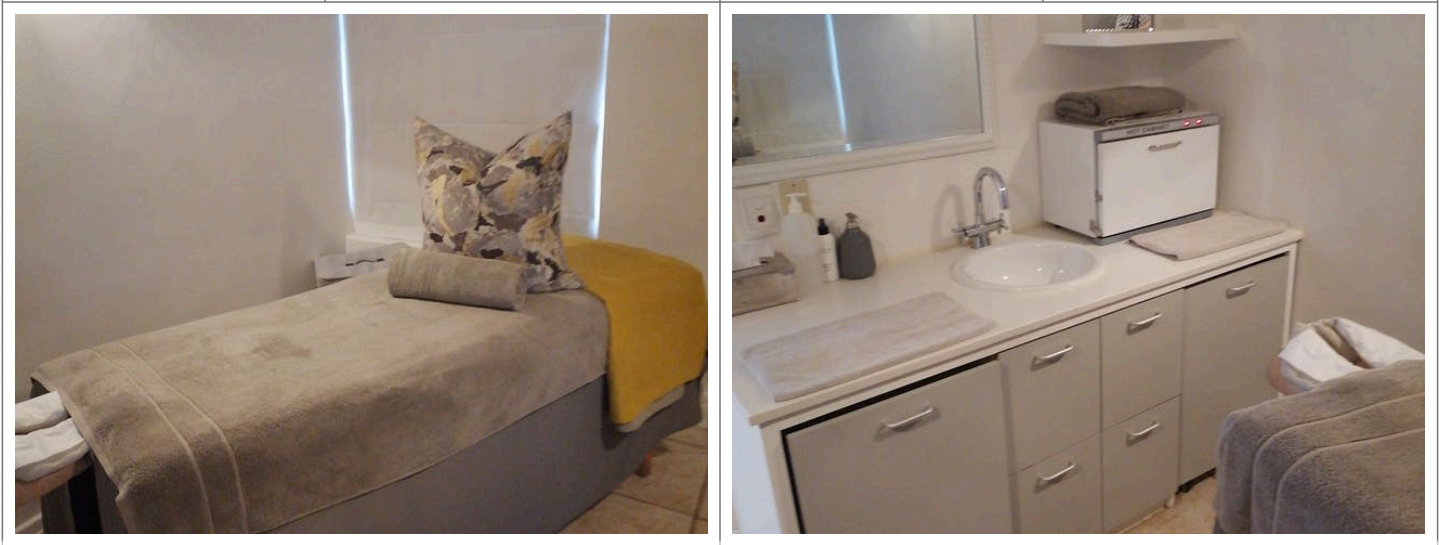
| Location | First floor room 5 | Item | No Asbestos |

| Material | No Asbestos Identified | Extent | |

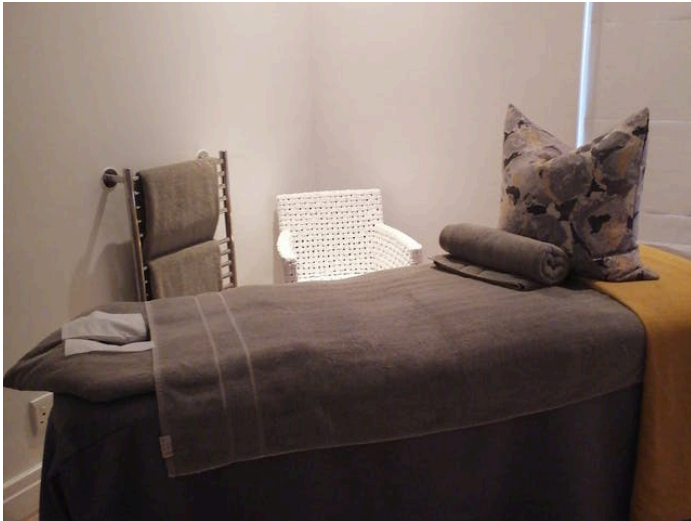
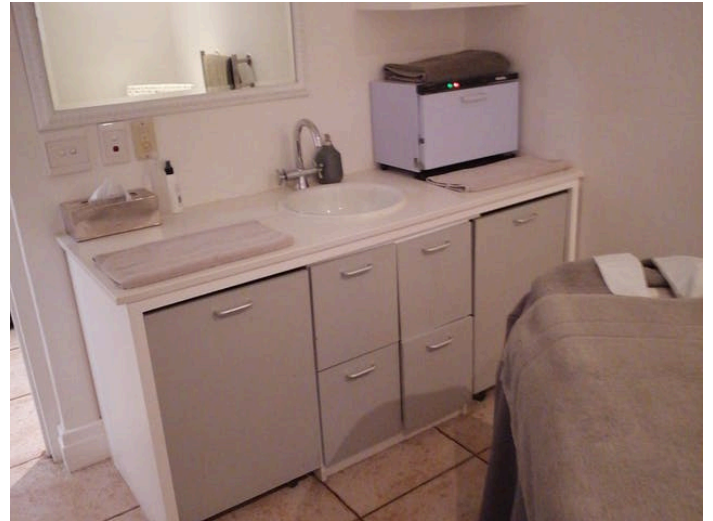
| Location | First floor room 6 | Item | No Asbestos |

| Material | No Asbestos Identified | Extent | |

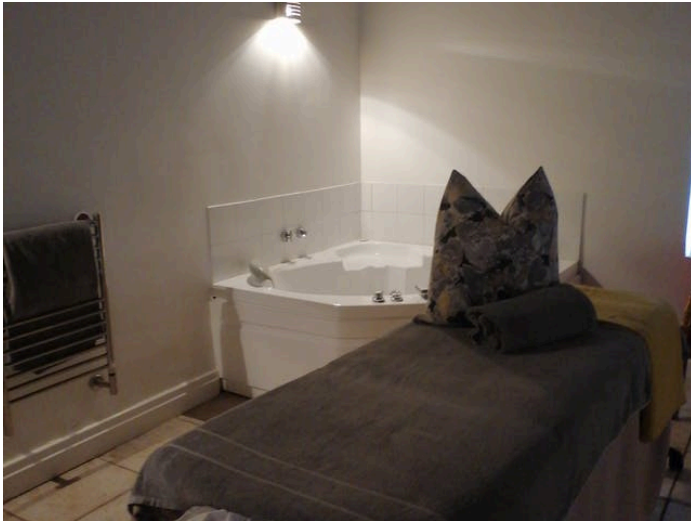
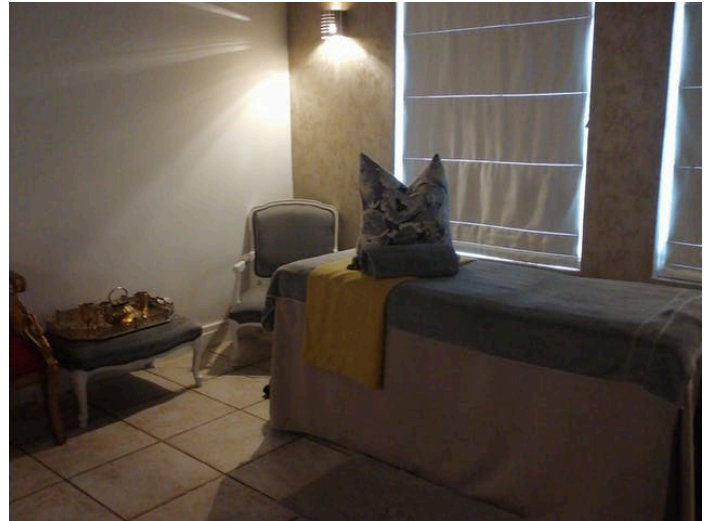
| Location | First floor room 7 | Item | No Asbestos |

| Material | No Asbestos Identified | Extent | |

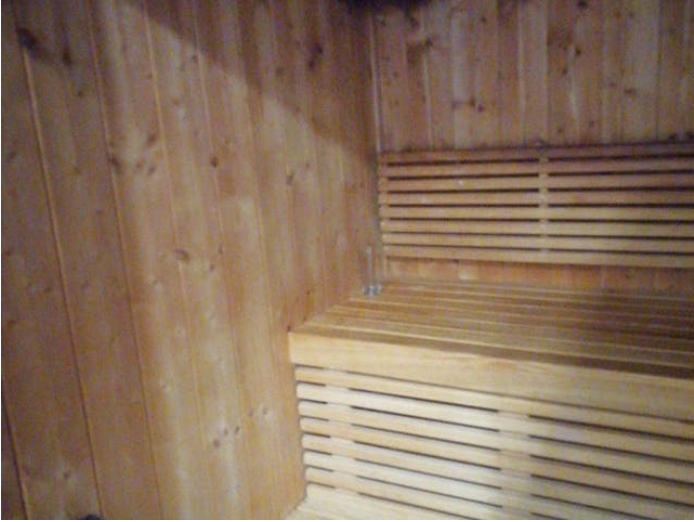
| Location | First floor sauna | Item | No Asbestos |

| Material | No Asbestos Identified | Extent | |

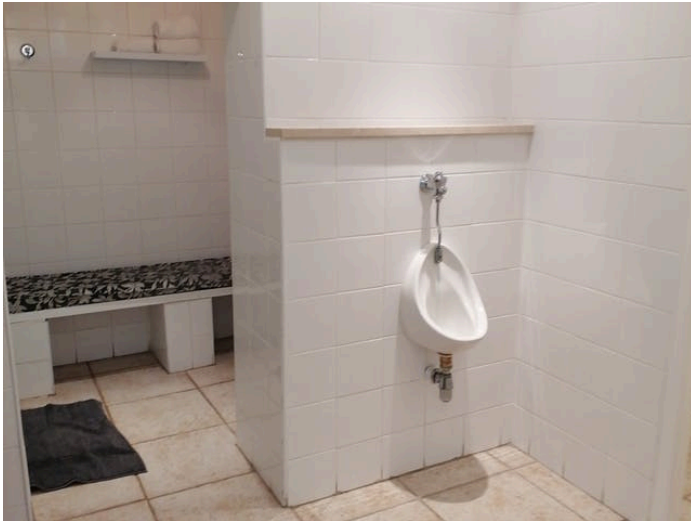
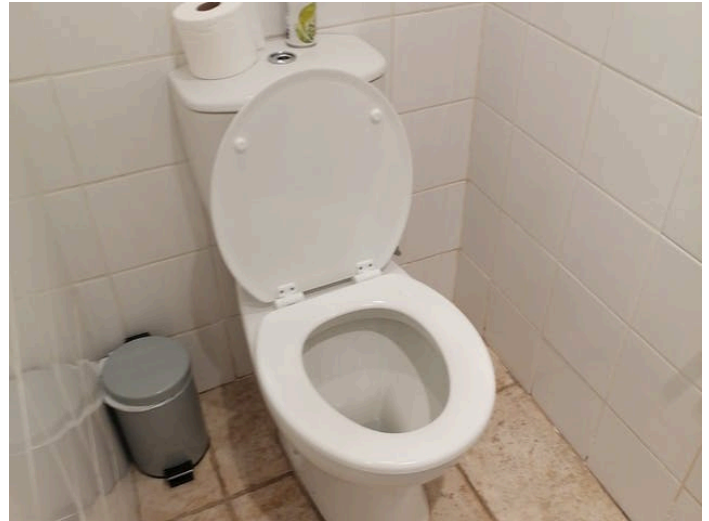
| Location | Ground floor bath room | Item | No Asbestos |

| Material | No Asbestos Identified | Extent | |

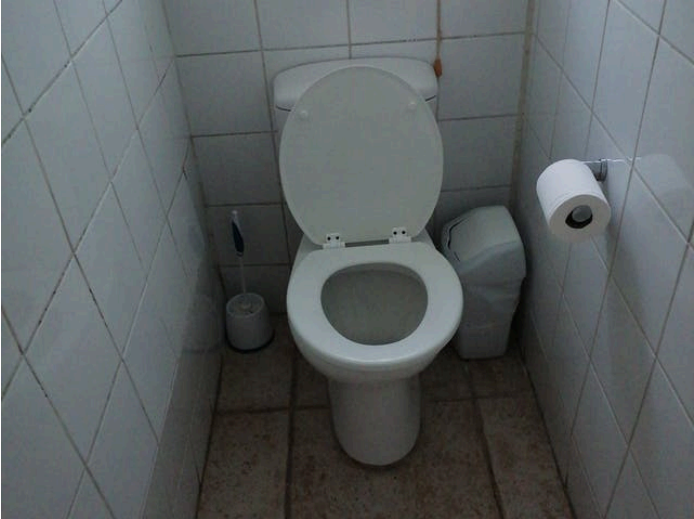
| Location | Ground floor bath room staff | Item | No Asbestos |

| Material | No Asbestos Identified | Extent | |

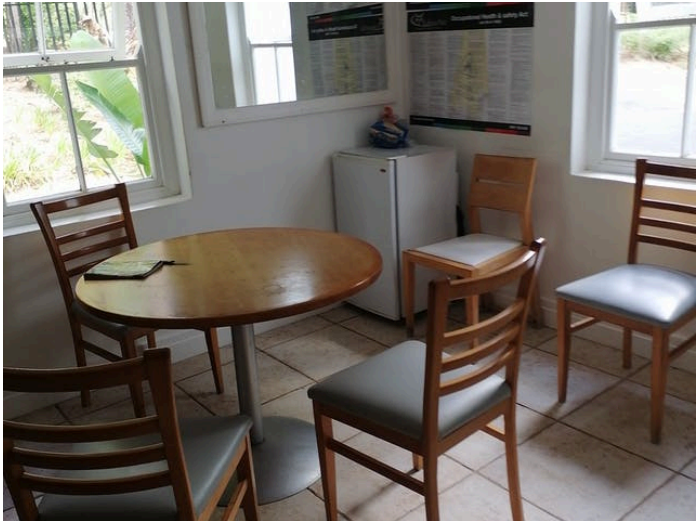
| Location | ground floor cafeteria | Item | No Asbestos |

| Material | No Asbestos Identified | Extent | |

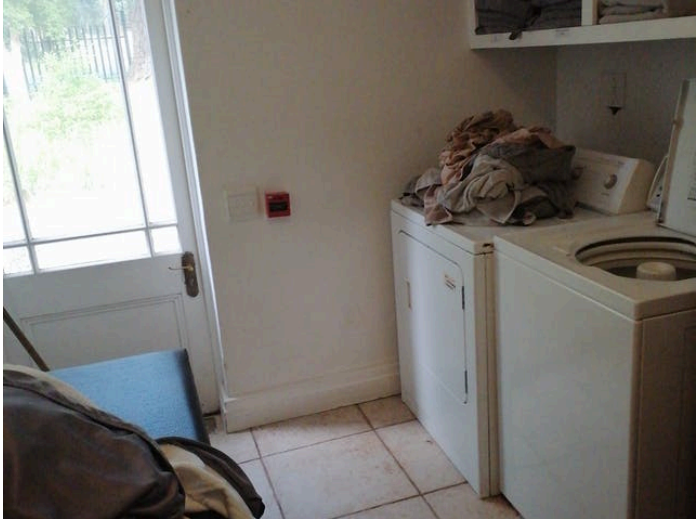
| Location | Ground floor laundry | Item | No Asbestos |

| Material | No Asbestos Identified | Extent | |

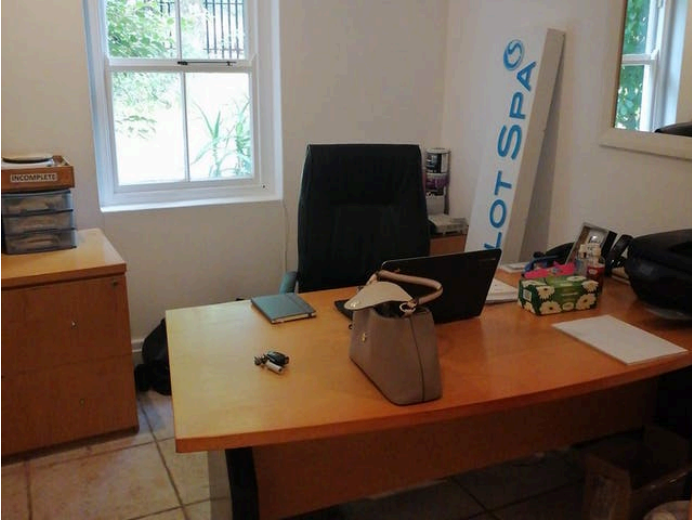
| Location | Ground floor office | Item | No Asbestos |

| Material | No Asbestos Identified | Extent | |

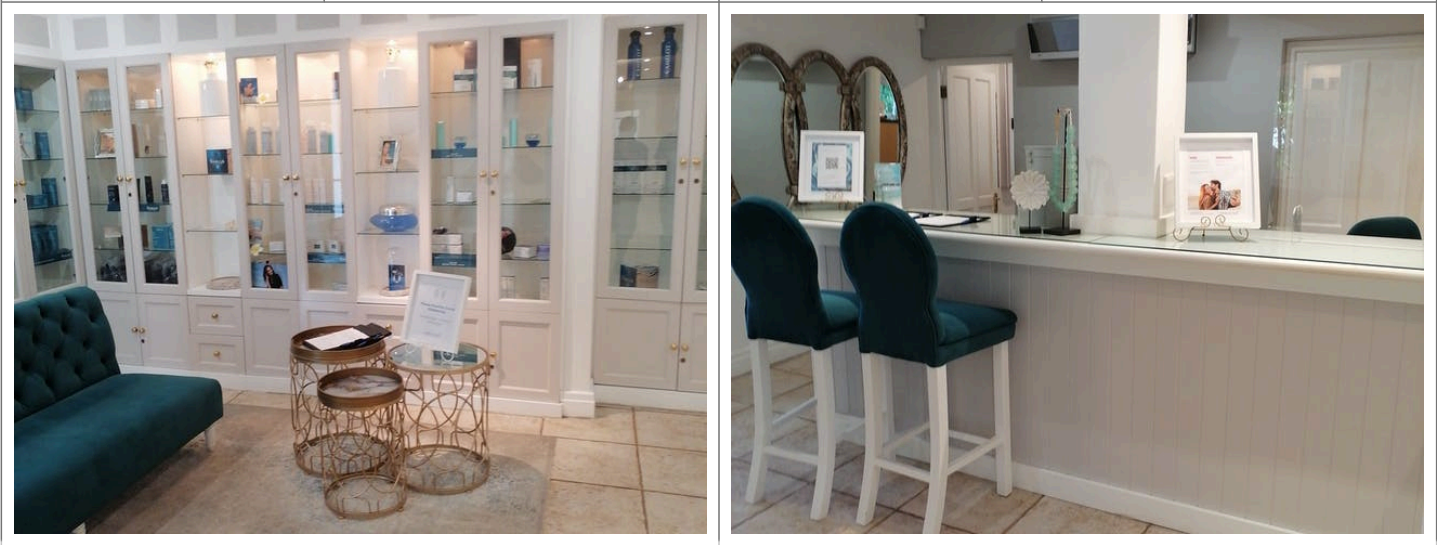
| Location | Ground floor Reception | Item | No Asbestos |

| Material | No Asbestos Identified | Extent | |

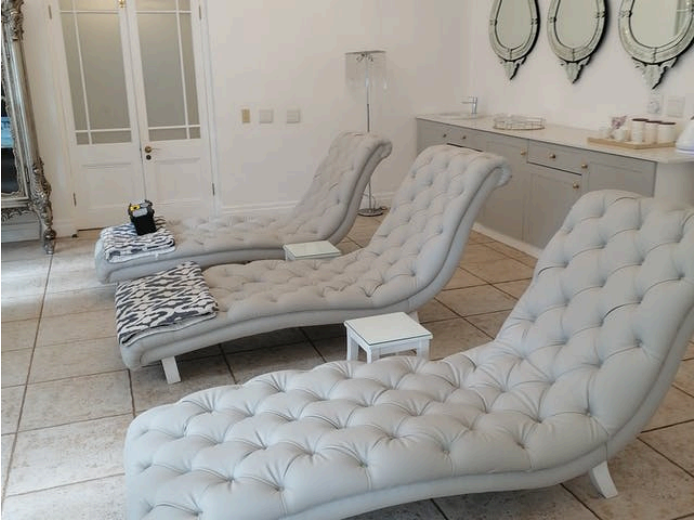
| Location | Ground floor room 1 | Item | No Asbestos |

| Material | No Asbestos Identified | Extent | |

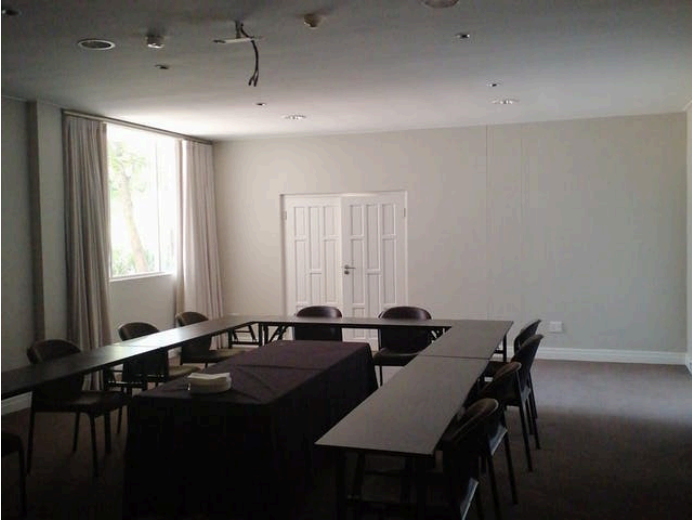
| Location | Chantilli room | Item | No Asbestos |

| Material | No Asbestos Identified | Extent | |

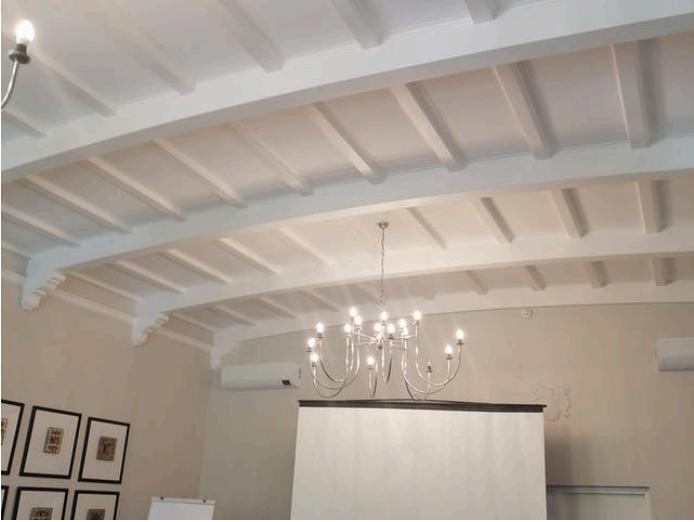
| Location | Fountainebleu | Item | No Asbestos |

| Material | No Asbestos Identified | Extent | |

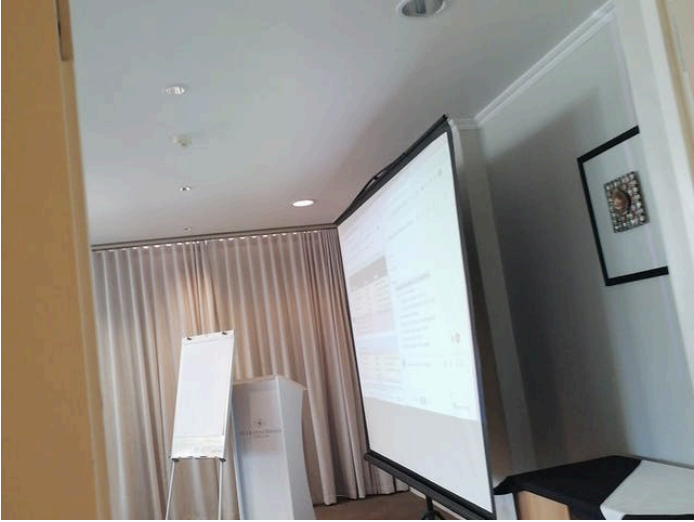
| Location | St Germaine | Item | No Asbestos |

| Material | No Asbestos Identified | Extent | |

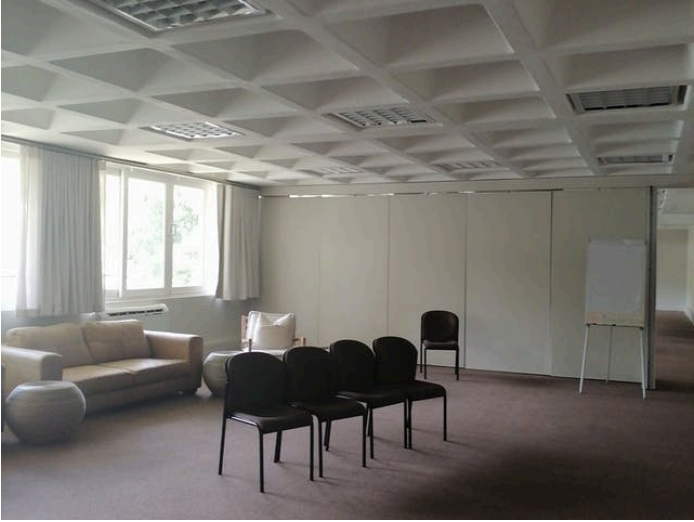
| Location | Versailles 1 | Item | No Asbestos |

| Material | No Asbestos Identified | Extent | |

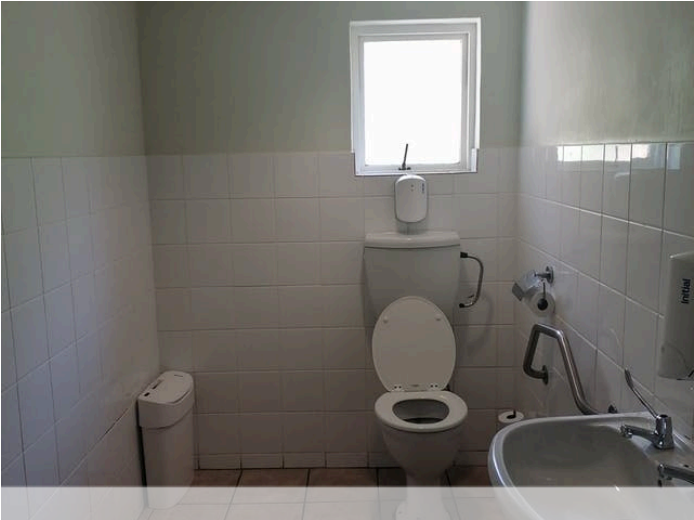
| Location | Versailles 1 handicap bath room | Item | No Asbestos |

| Material | No Asbestos Identified | Extent | |

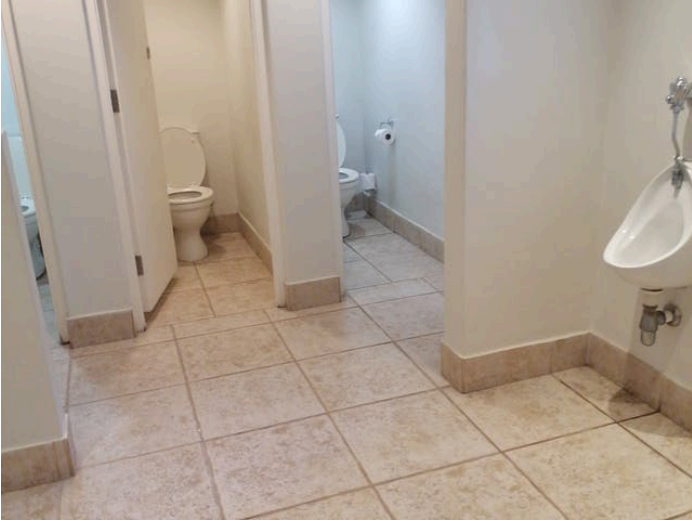
| Location | Versailles 1 men's bath room | Item | No Asbestos |

| Material | No Asbestos Identified | Extent | |

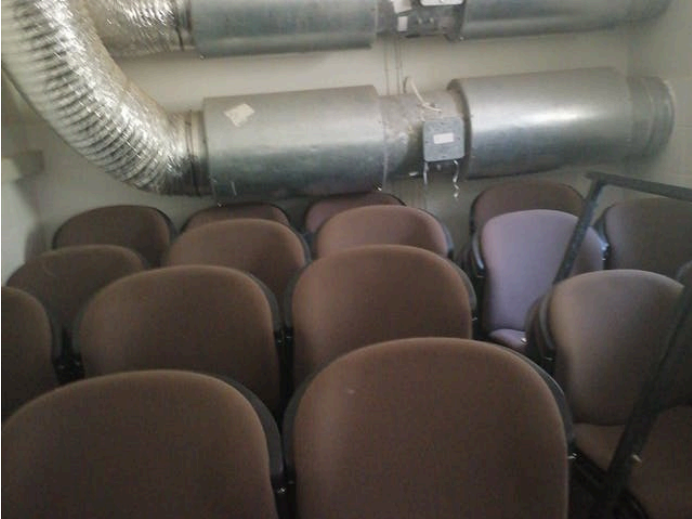
| Location | Versailles 1 store room | Item | No Asbestos |

| Material | No Asbestos Identified | Extent | |

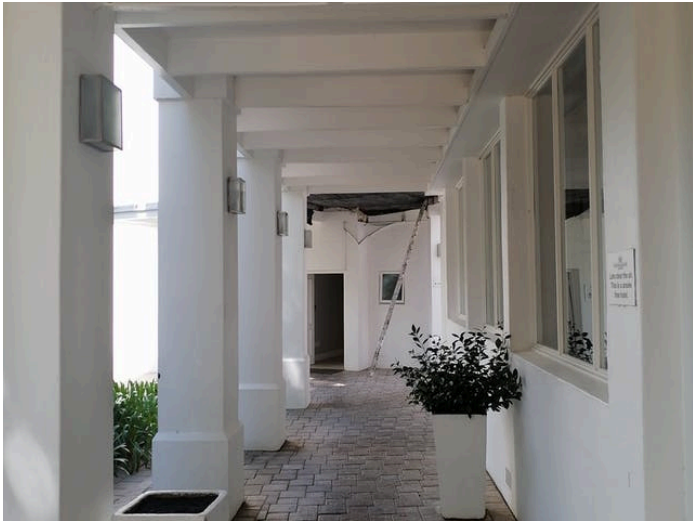
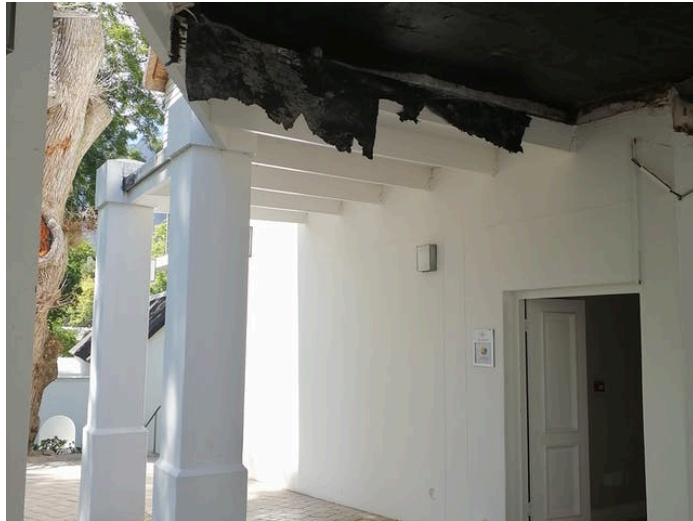
| Location | Versailles entrance | Item | No Asbestos |

| Material | No Asbestos Identified | Extent | |
| General Comments | 29 x 2.5 | | |

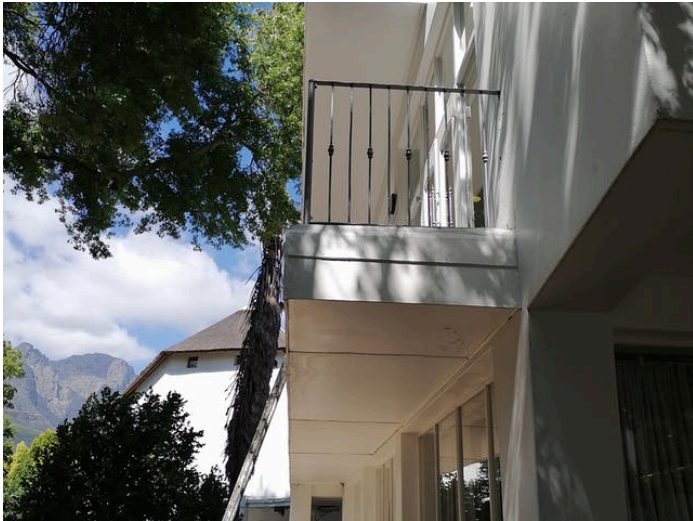
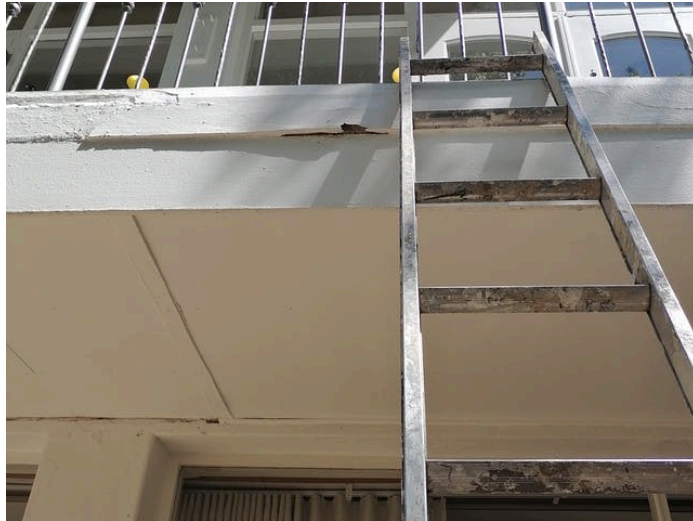
| Location | Restaurant stoep facias | Item | Facias |

| Material | Compressed | Extent | |
| General Comments | 34 meter | | |

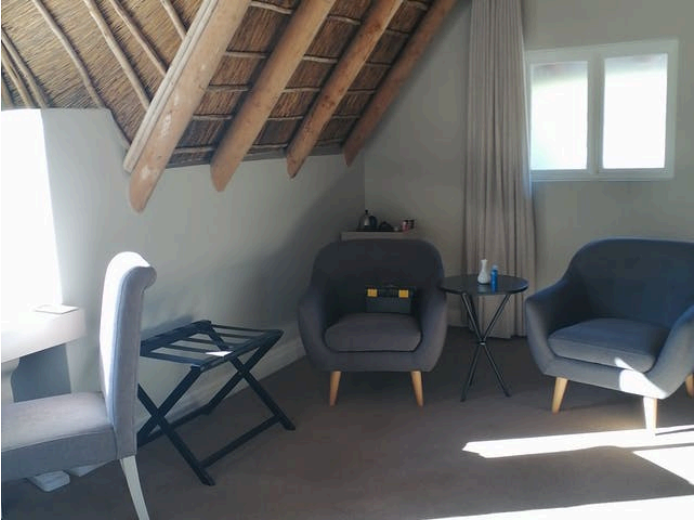
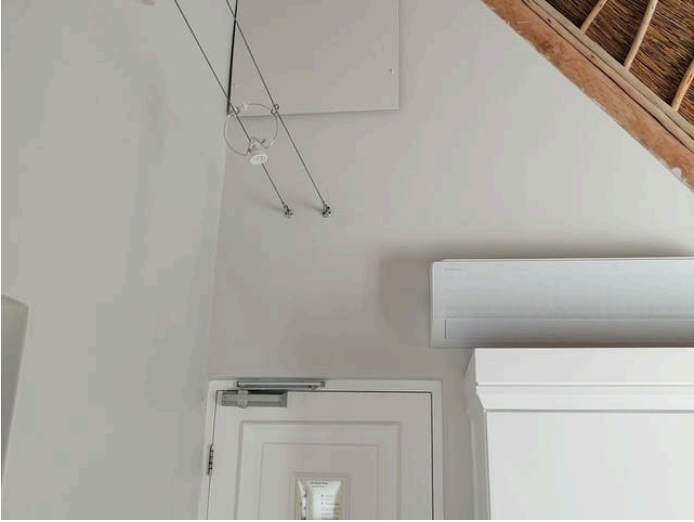
| Location | Room 15 | Item | No Asbestos |

| Material | No Asbestos Identified | Extent | |

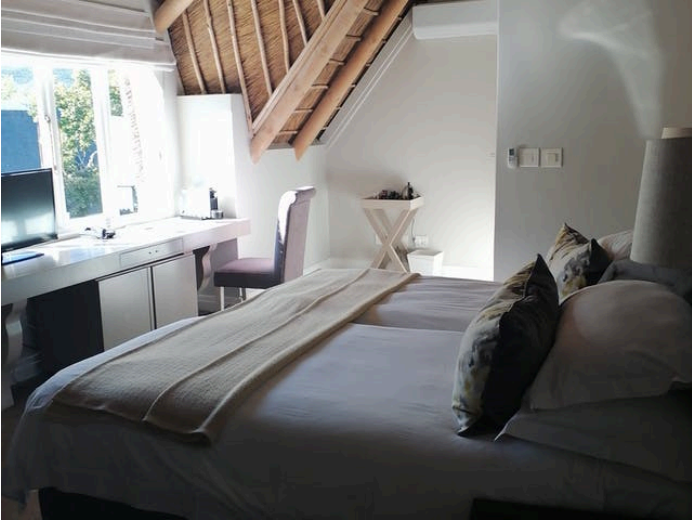
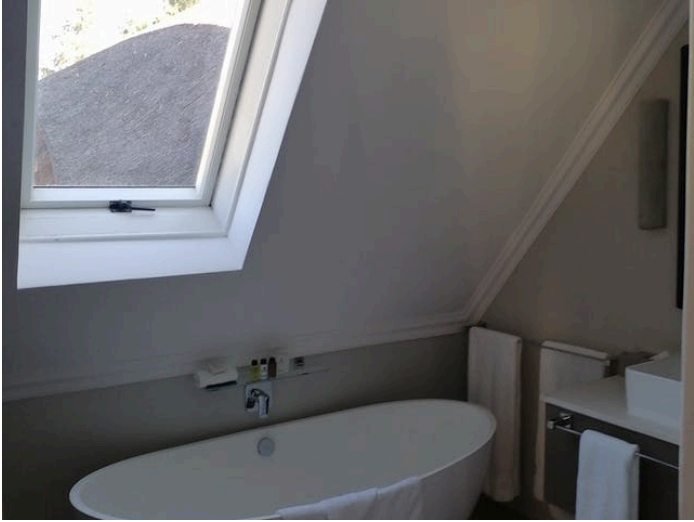
| Location | Room 16 | Item | No Asbestos |

| Material | No Asbestos Identified | Extent | |

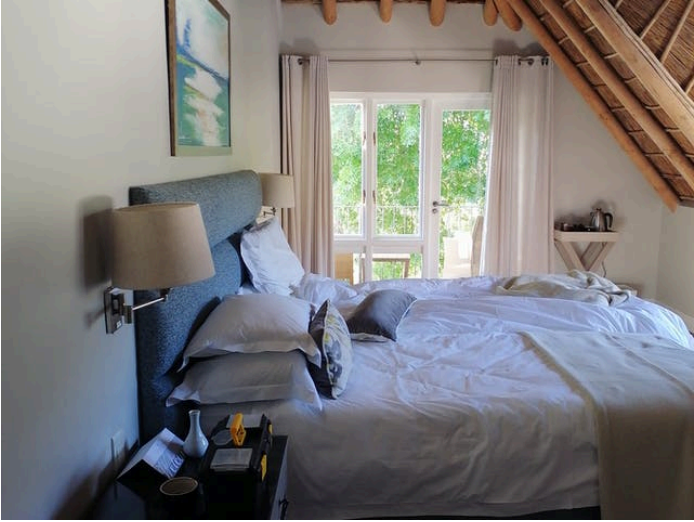
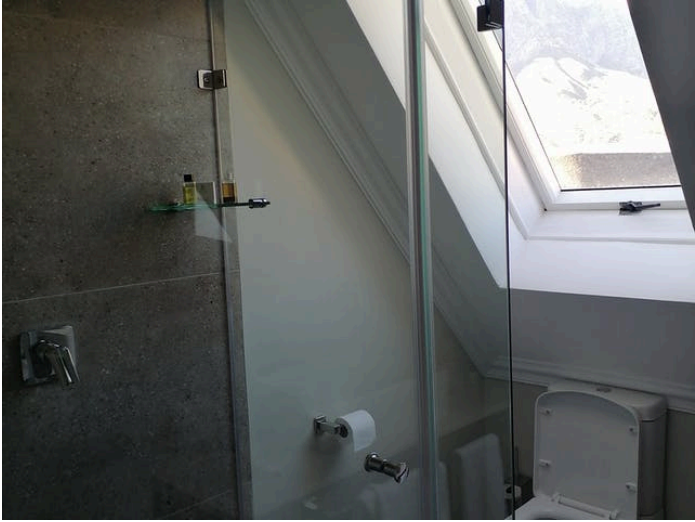
| Location | Room 18 | Item | No Asbestos |

| Material | No Asbestos Identified | Extent | |

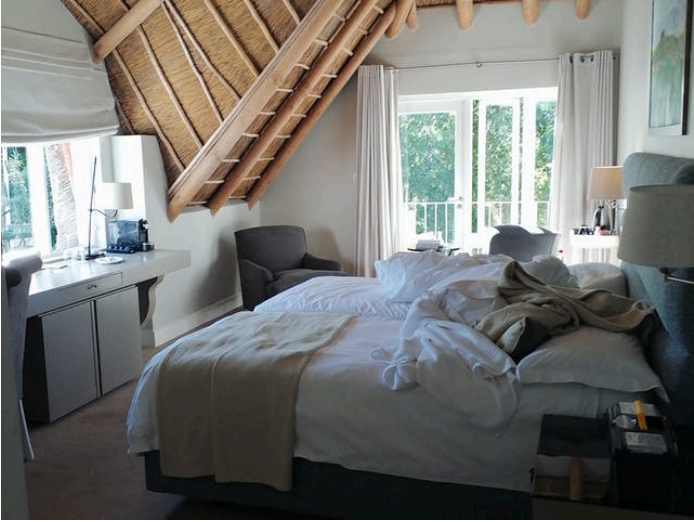
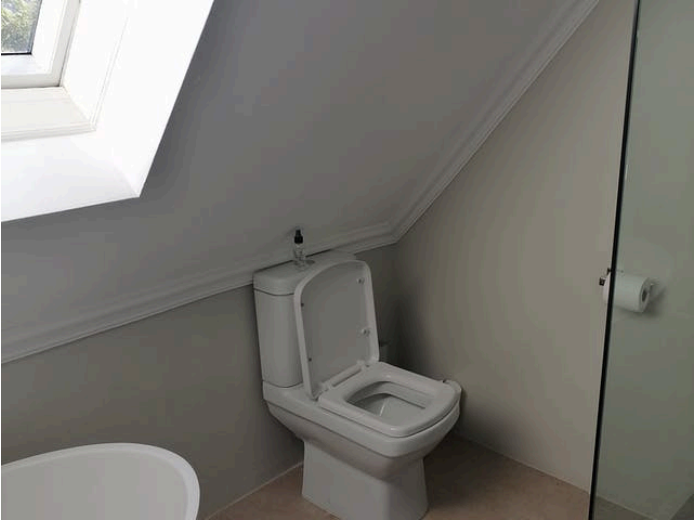
| Location | Room 19 | Item | No Asbestos |

| Material | No Asbestos Identified | Extent | |

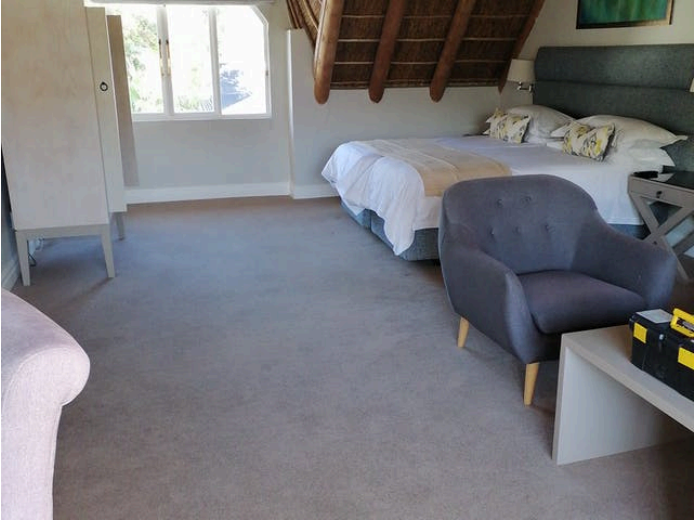
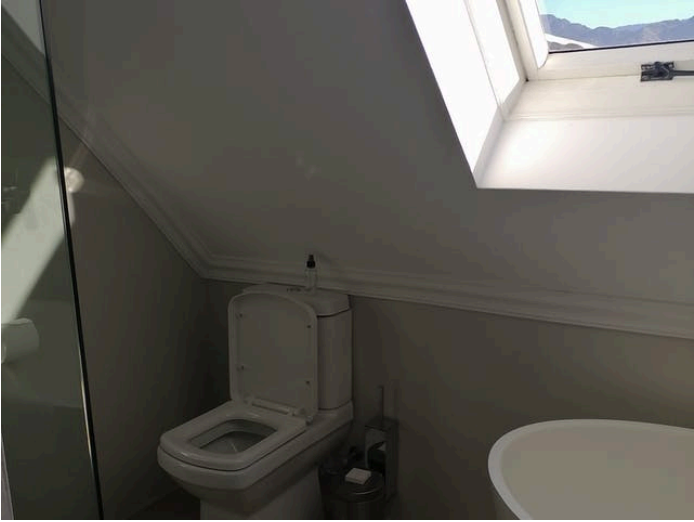
| Location | Room 20 | Item | No Asbestos |

| Material | No Asbestos Identified | Extent | |

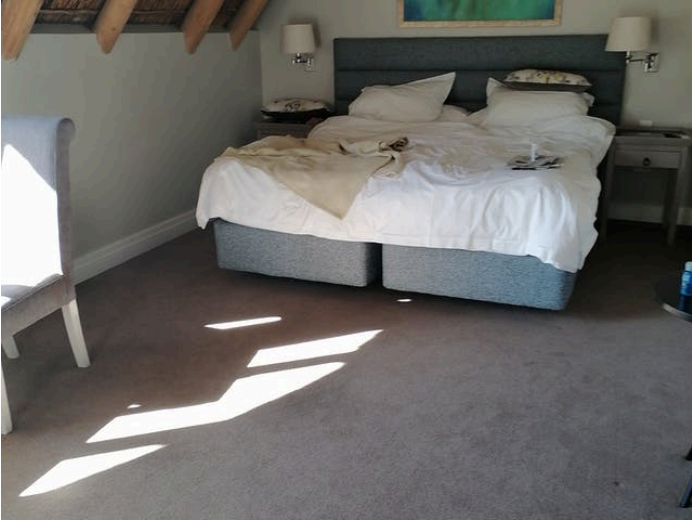
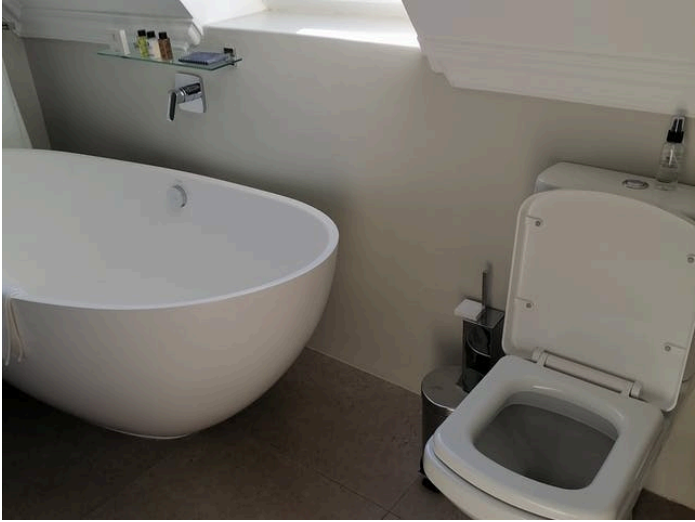
| Location | Room 21 | Item | No Asbestos |

| Material | No Asbestos Identified | Extent | |

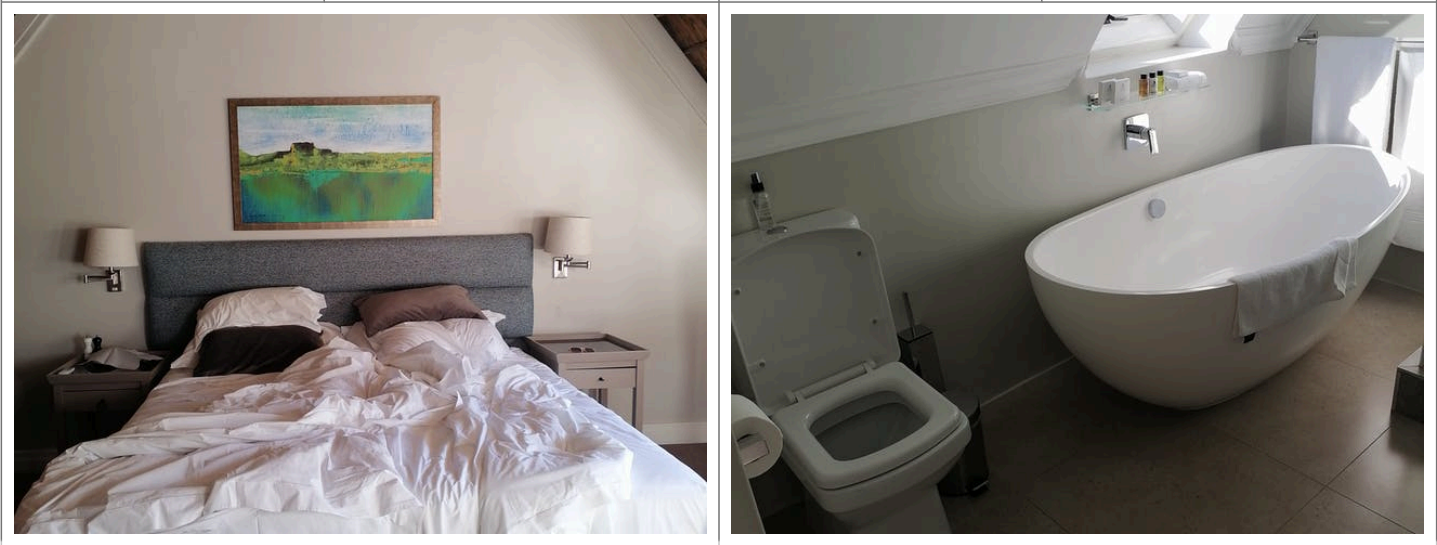
| Location | Room 22 | Item | No Asbestos |

| Material | No Asbestos Identified | Extent | |

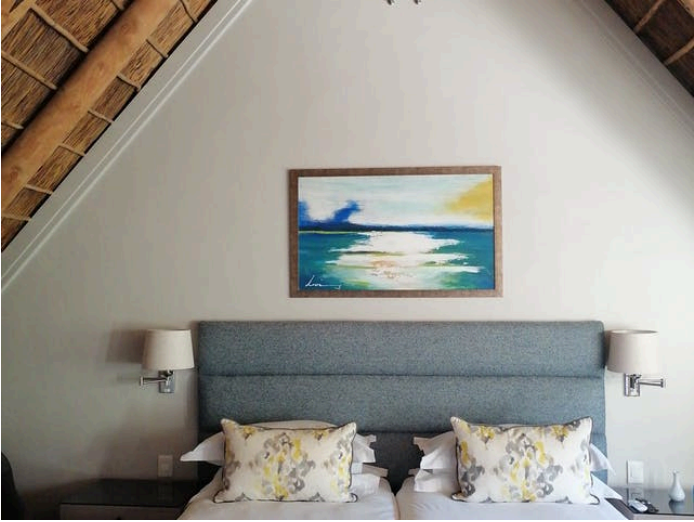
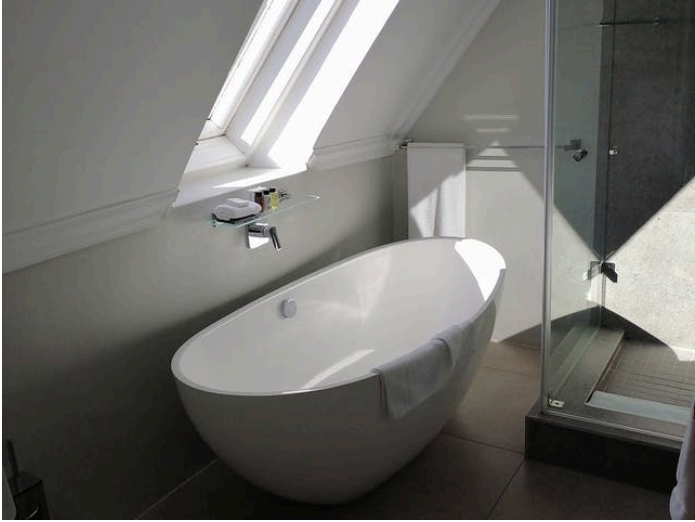
| Location | Room 24 | Item | No Asbestos |

| Material | No Asbestos Identified | Extent | |

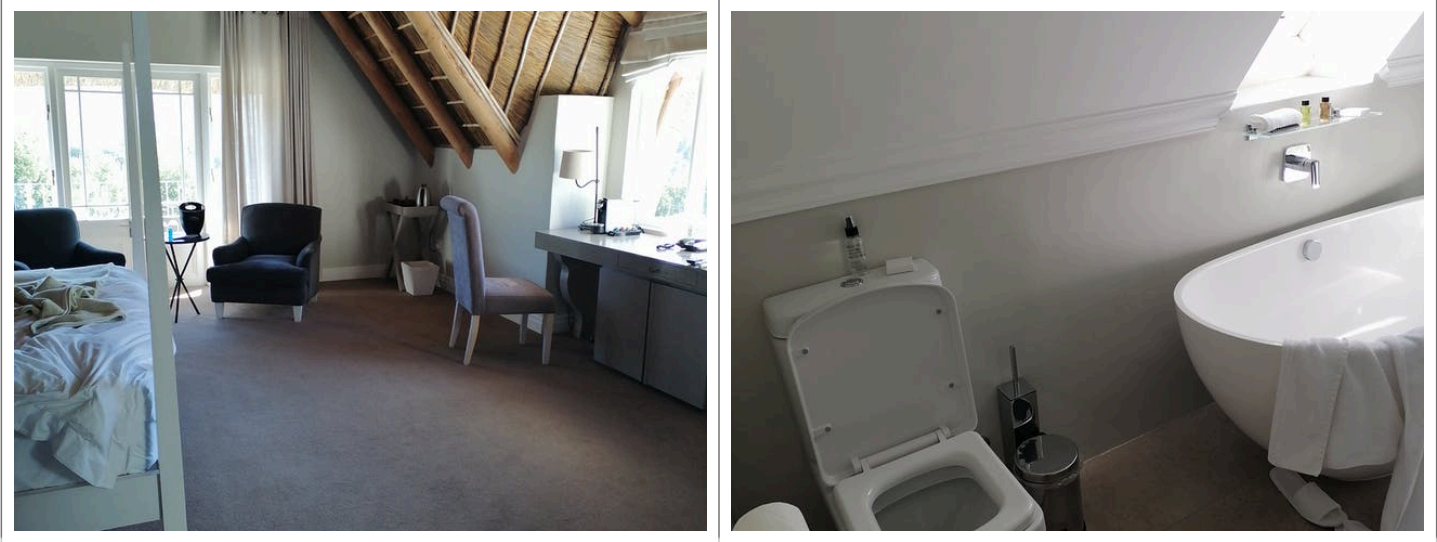
| Location | Room 26 | Item | No Asbestos |

| Material | No Asbestos Identified | Extent | |

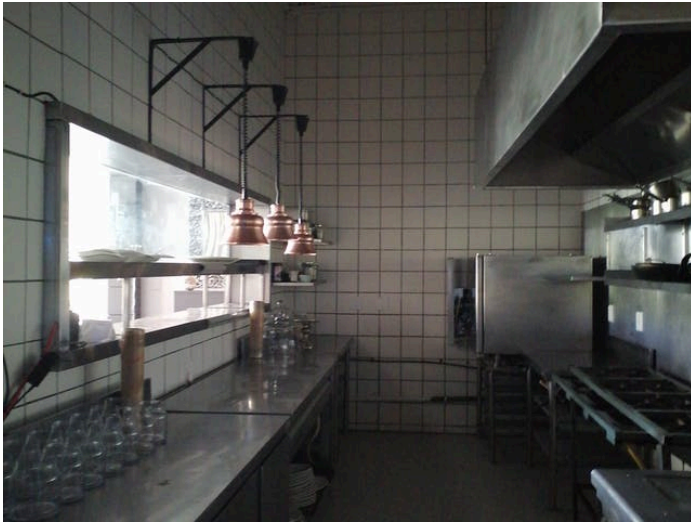
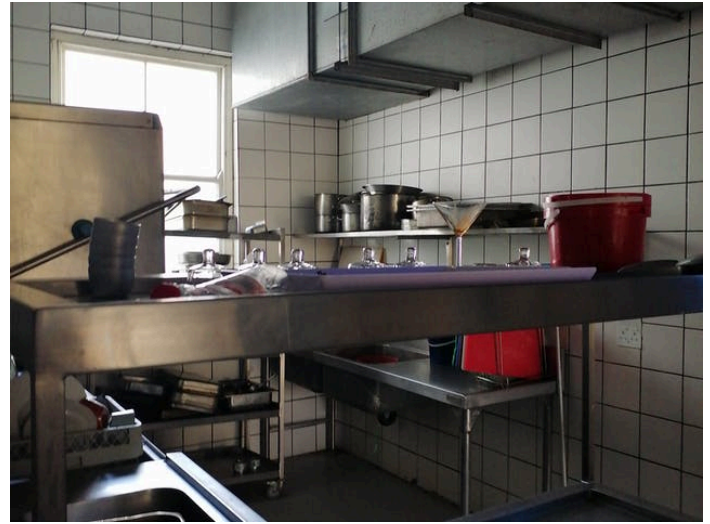
| Location | Sauvage kitchen | Item | No Asbestos |

| Material | No Asbestos Identified | Extent | |
