# ASBESTOS MANAGEMENT SURVEY

16 Minor road, Franschhoek, 7690

Asbestos identification and inventory

| Client | Franschhoek Hotel & Spa |

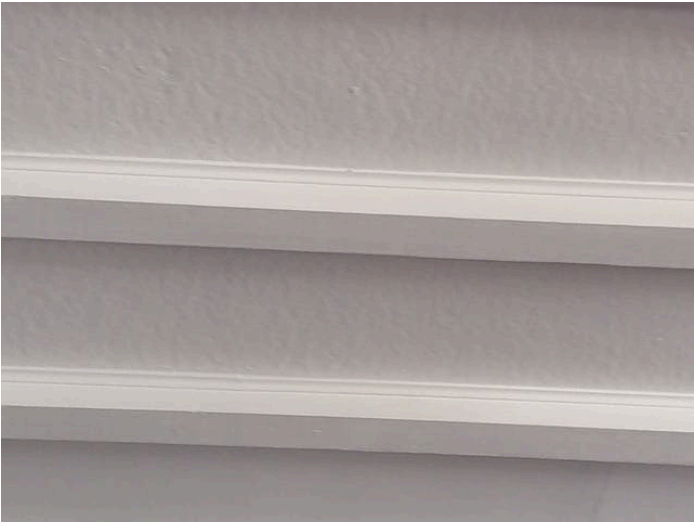
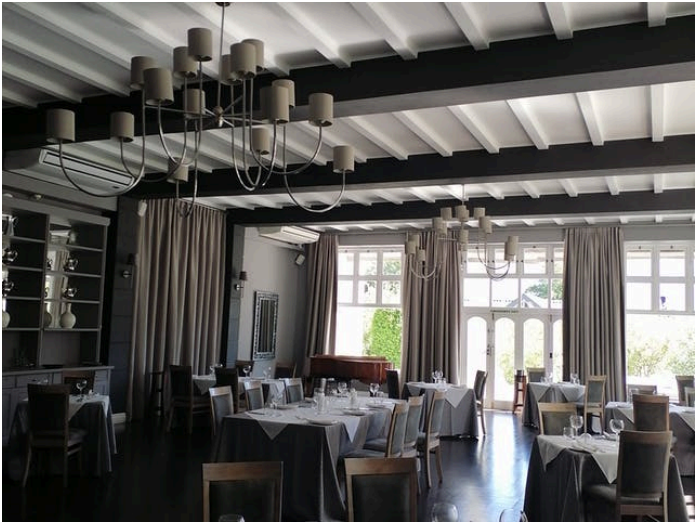
| Location | Sauvage restuarant | Item | No Asbestos |

| Material | No Asbestos Identified | Extent | |

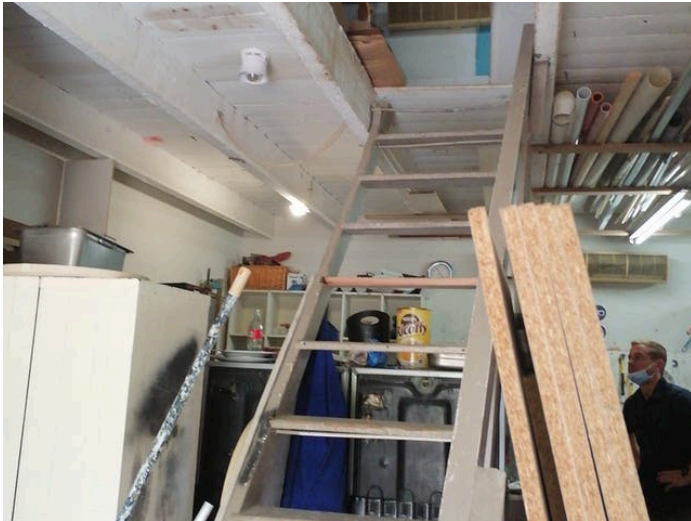
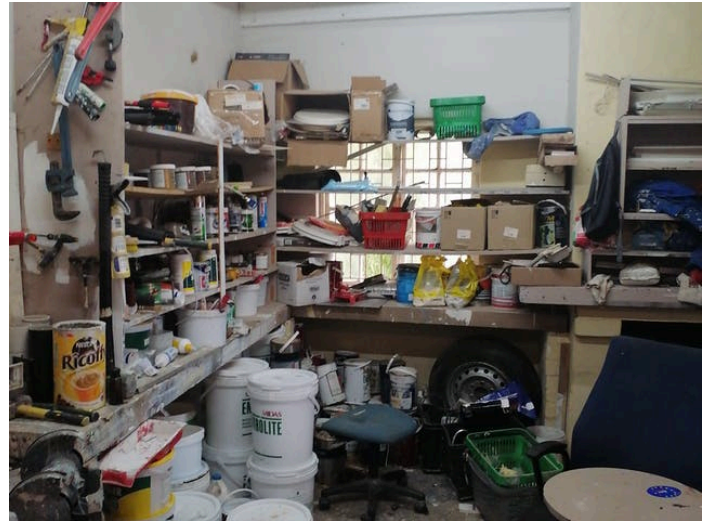
| Location | Maintenance room | Item | No Asbestos |

| Material | No Asbestos Identified | Extent | |

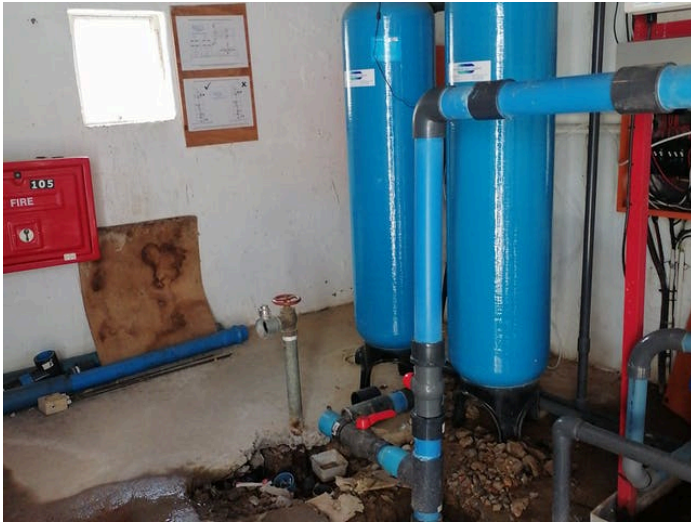
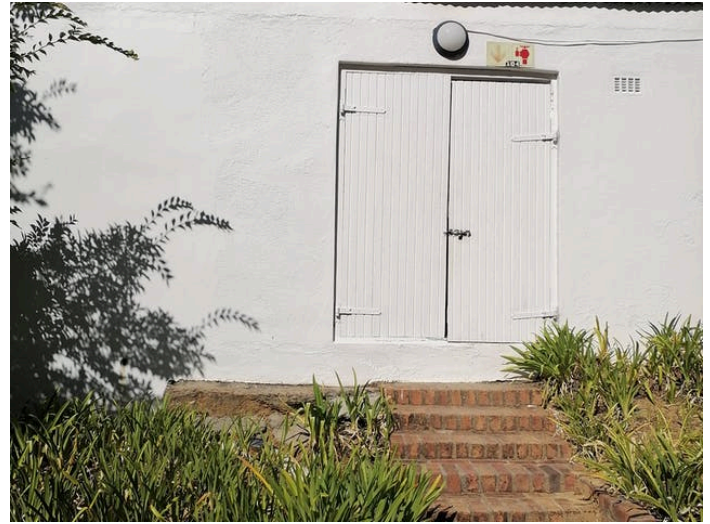
| Location | Pump room | Item | No Asbestos |

| Material | No Asbestos Identified | Extent | |

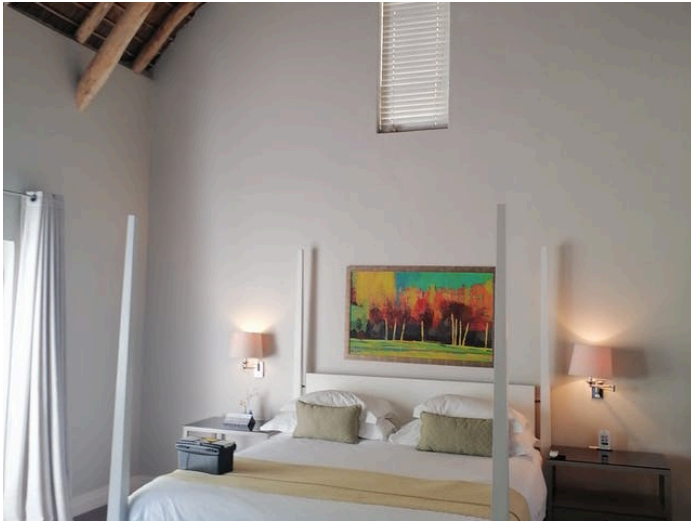
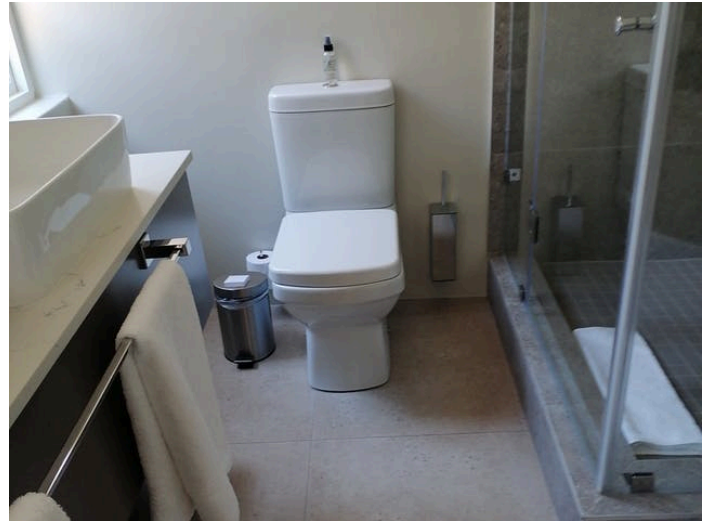
| Location | Room 45 | Item | No Asbestos |

| Material | No Asbestos Identified | Extent | |

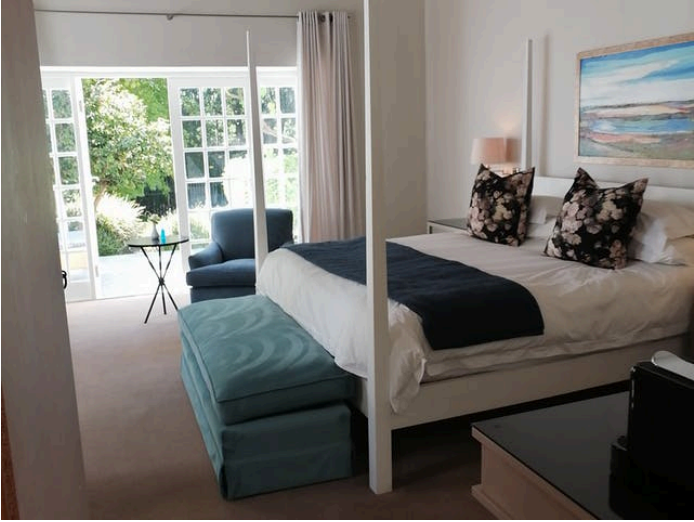
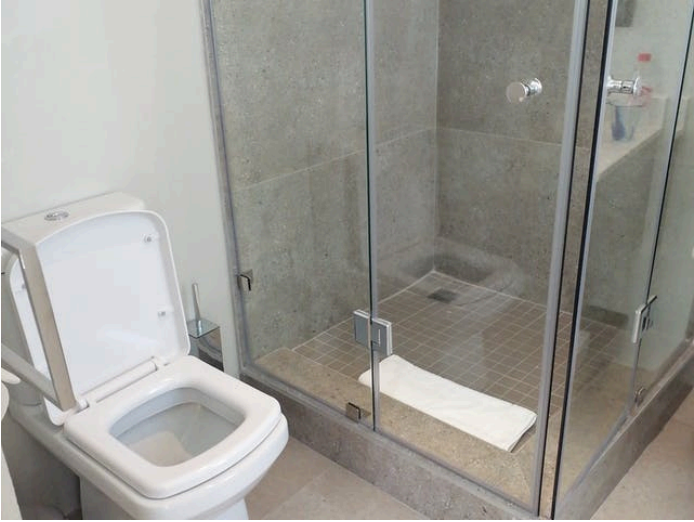
| Location | Room 46 | Item | No Asbestos |

| Material | No Asbestos Identified | Extent | |

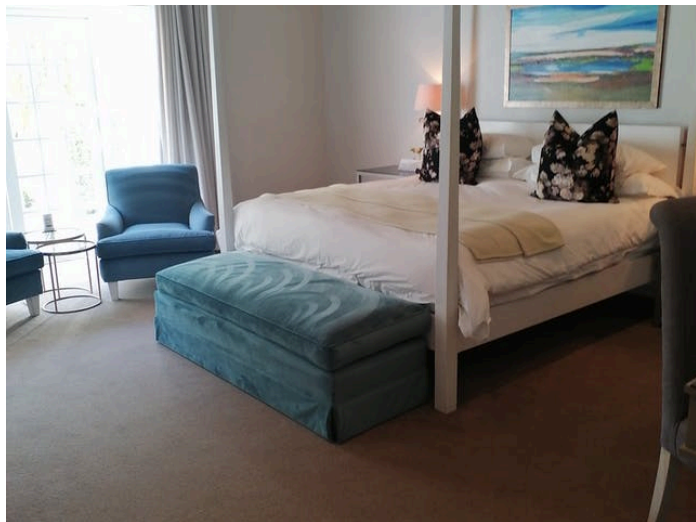
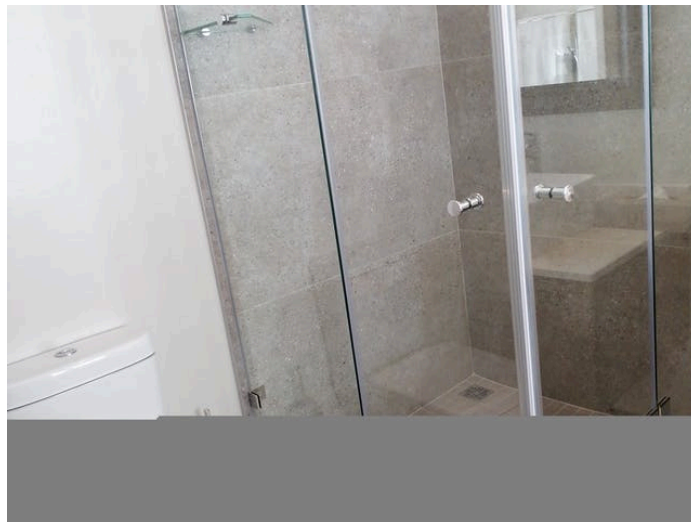
| Location | Room 47 | Item | No Asbestos |

| Material | No Asbestos Identified | Extent | |

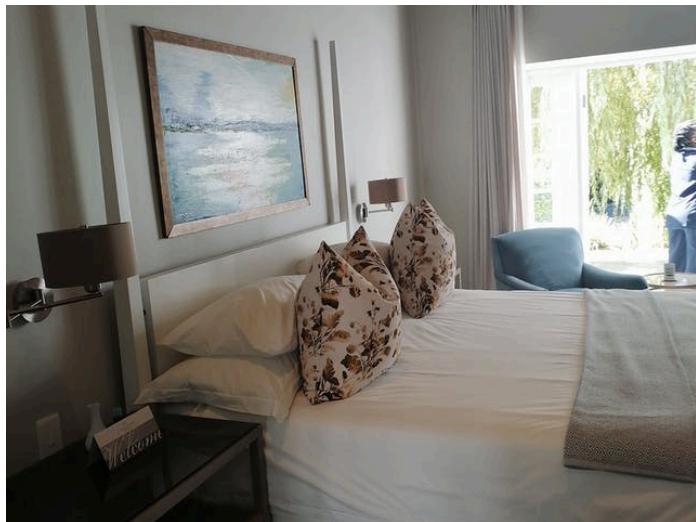
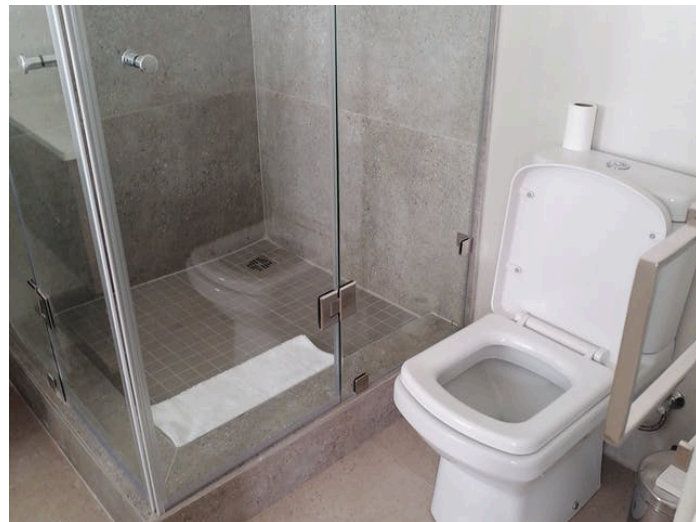
| Location | Room 48 | Item | No Asbestos |

| Material | No Asbestos Identified | Extent | |

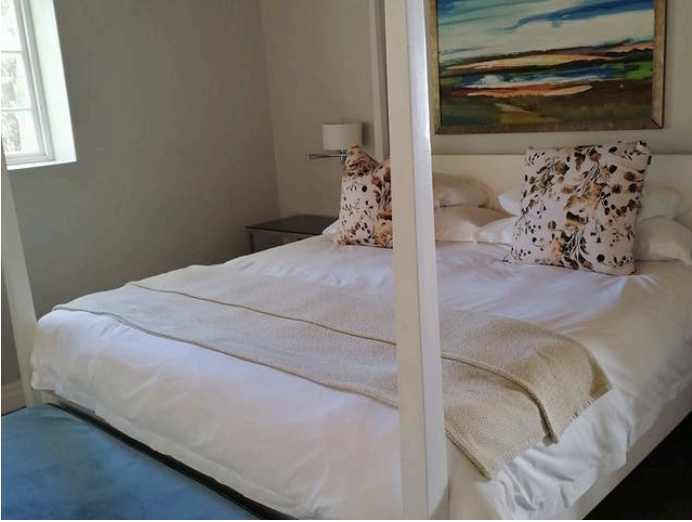
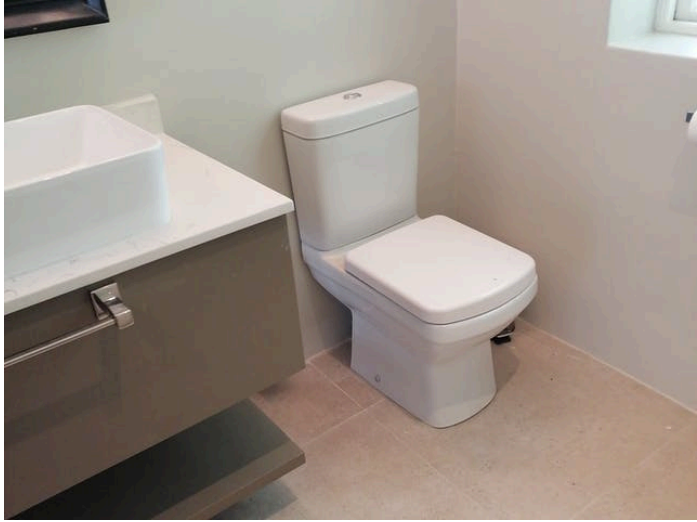
## River Suite > > Room 49 > No Asbestos

| Material | No Asbestos Identified | Extent | |

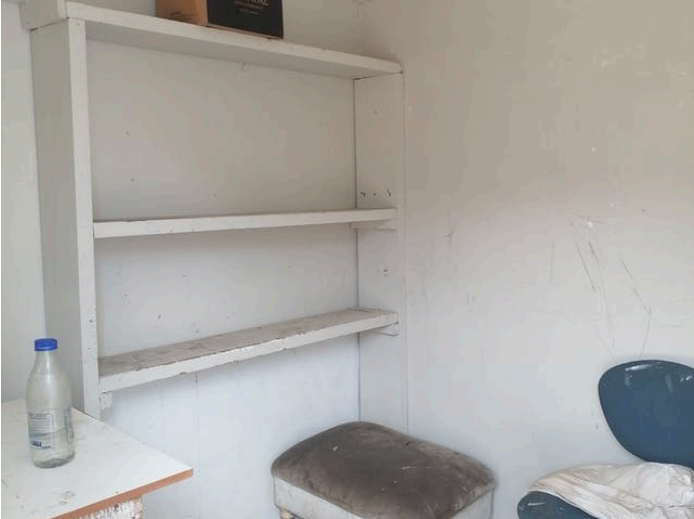
Security gate > > Back entrance > No Asbestos

| Material | No Asbestos Identified | Extent | |

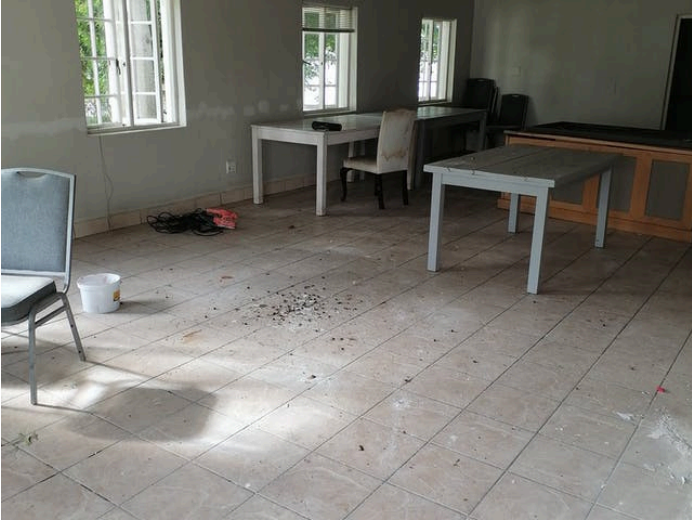
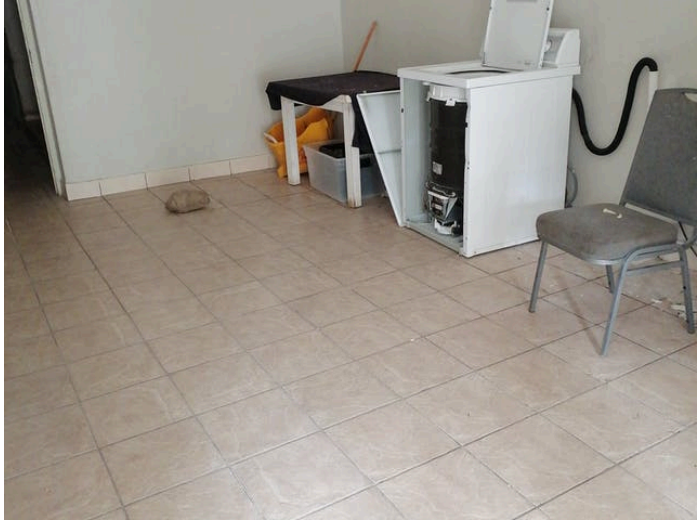
## Staff house > > Entrance > No Asbestos

| Material | No Asbestos Identified | Extent | |

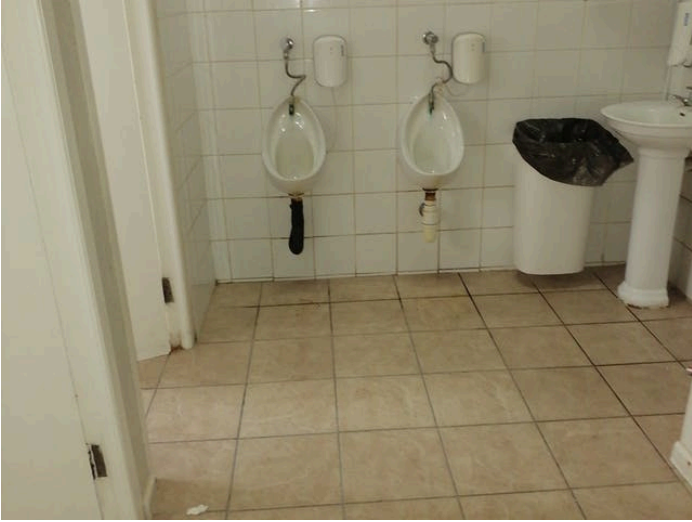
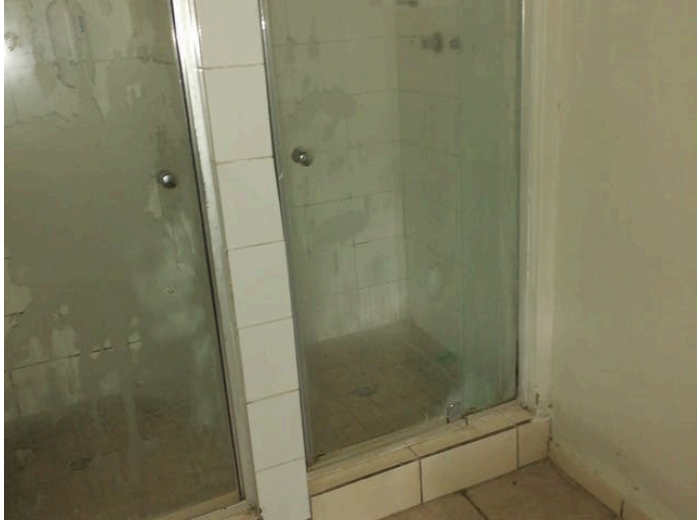
## Staff house > > Ground floor men's toilet > No Asbestos

| Material | No Asbestos Identified | Extent | |

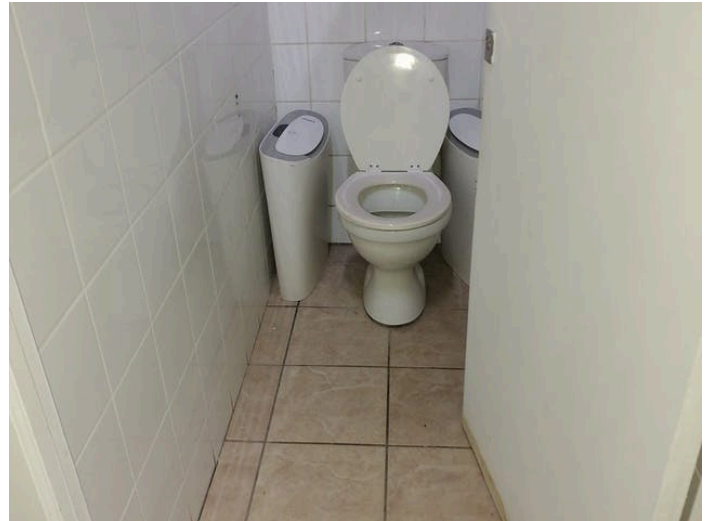
## Staff house > > Ground floor women's toilet > No Asbestos

| Material | No Asbestos Identified | Extent | |

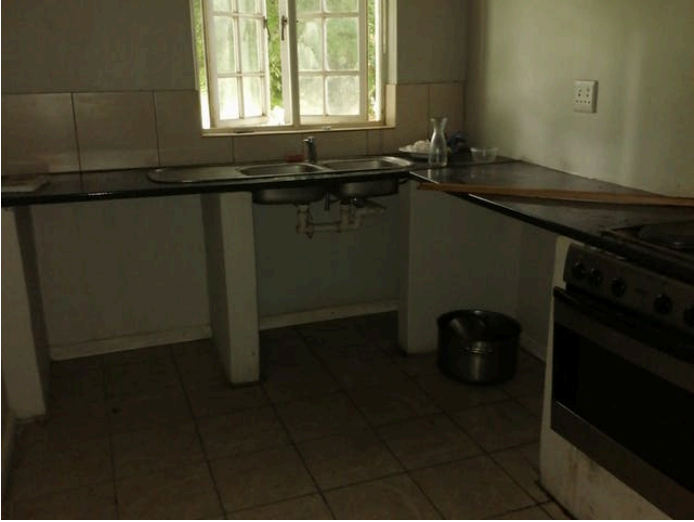
Staff house > > Kitchen > No Asbestos

| Material | No Asbestos Identified | Extent | |

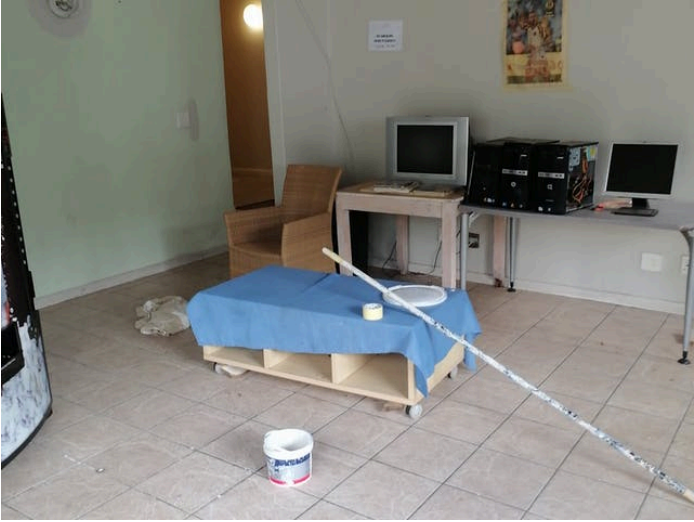
Staff house > > Lounge > No Asbestos

| Material | No Asbestos Identified | Extent | |

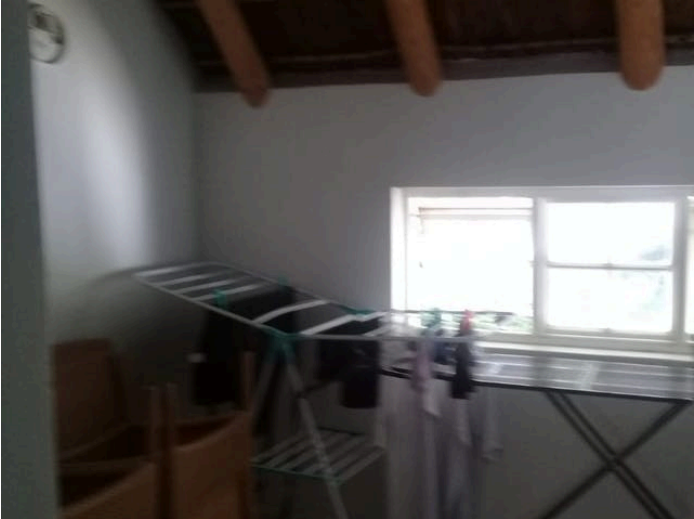
Staff House > > Room 1 > No Asbestos

| Material | No Asbestos Identified | Extent | |

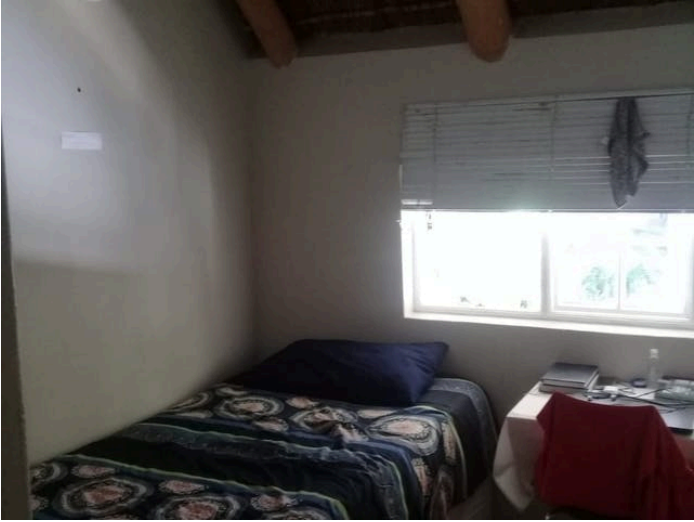
Staff house > > Room 2 > No Asbestos

| Material | No Asbestos Identified | Extent | |

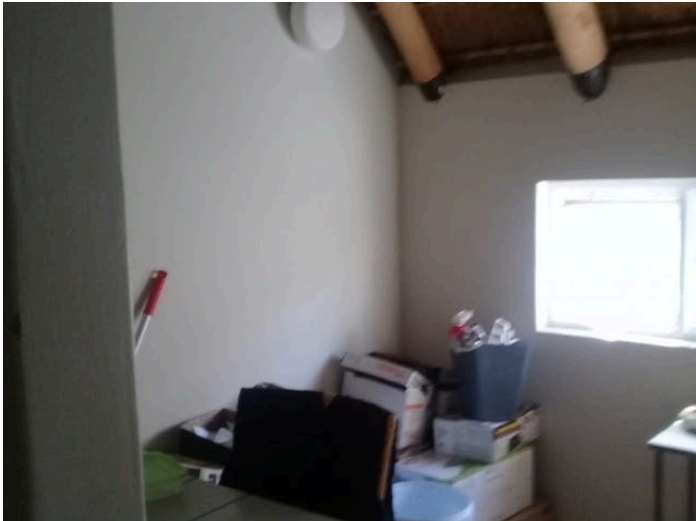
Staff house > > Room 3 > No Asbestos

| Material | No Asbestos Identified | Extent | |

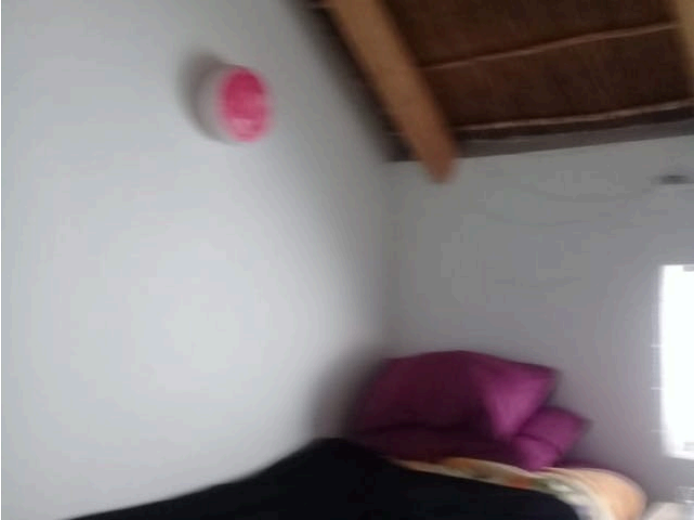
Staff house > > Room 4 > No Asbestos

| Material | No Asbestos Identified | Extent | |

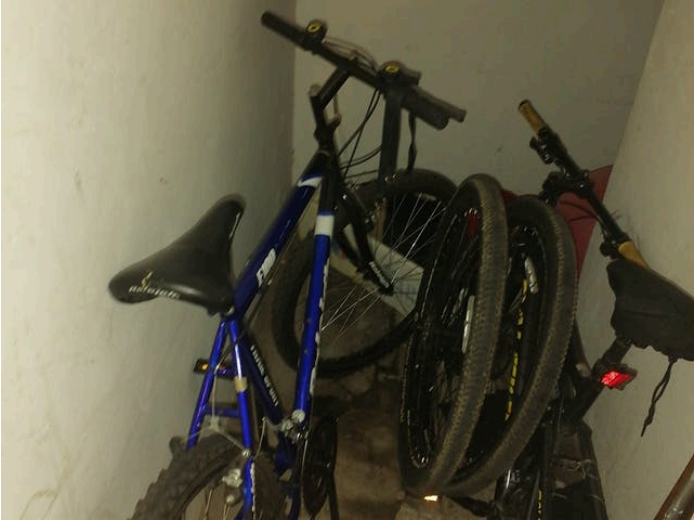
Staff house > > Store > No Asbestos

| Material | No Asbestos Identified | Extent | |

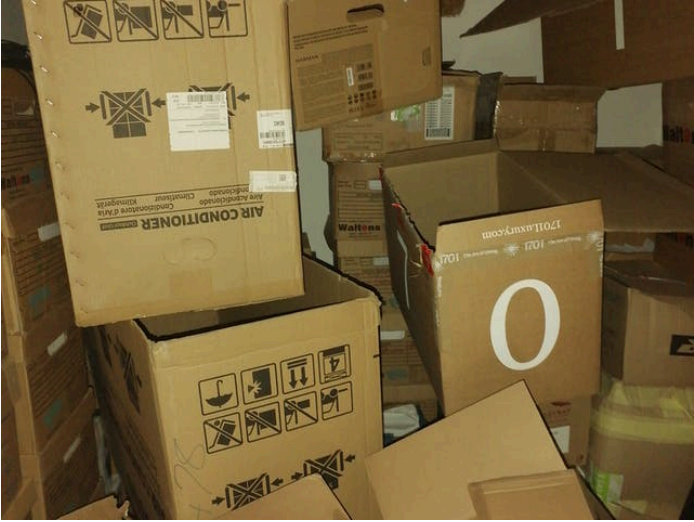
Staff house > > Store room first floor > No Asbestos

| Material | No Asbestos Identified | Extent | |

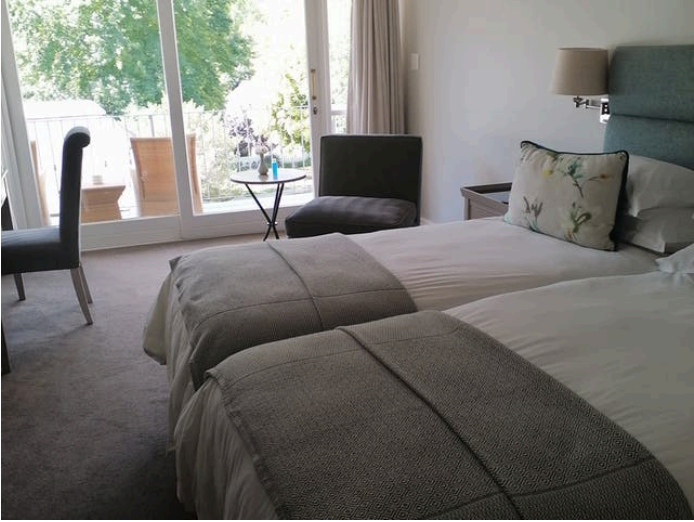
Valley Suites > > Room 27 > No Asbestos

| Material | No Asbestos Identified | Extent | |

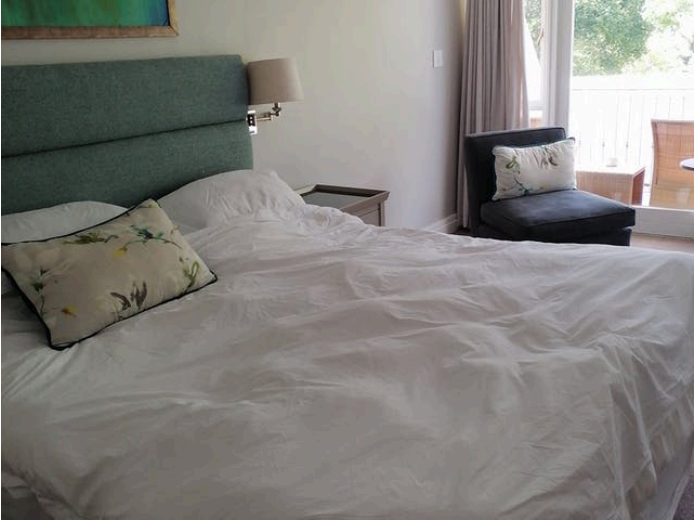
Valley Suites > > Room 28 > No Asbestos

| Material | No Asbestos Identified | Extent | |

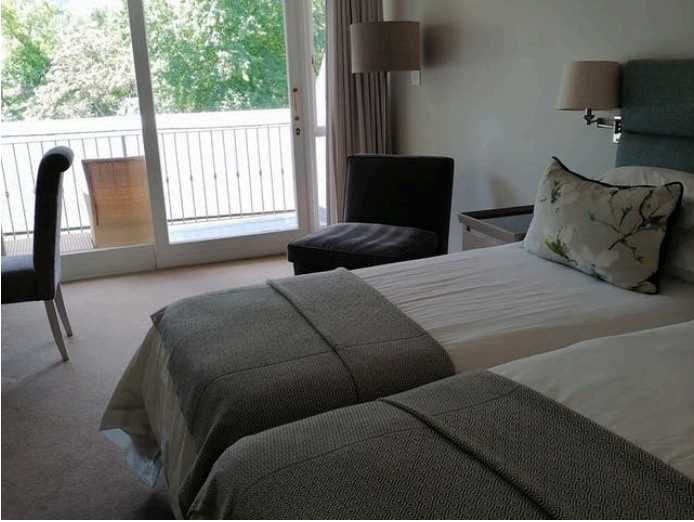
Valley Suites > > Room 29 > No Asbestos

| Material | No Asbestos Identified | Extent | |

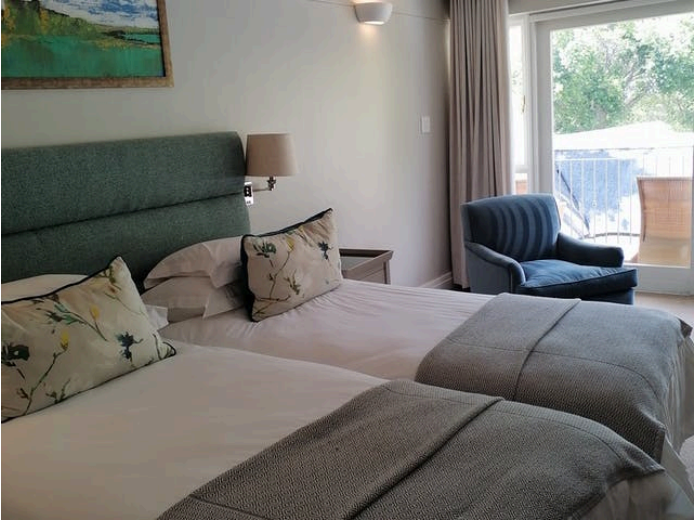
Valley Suites > > Room 30 > No Asbestos

| Material | No Asbestos Identified | Extent | |

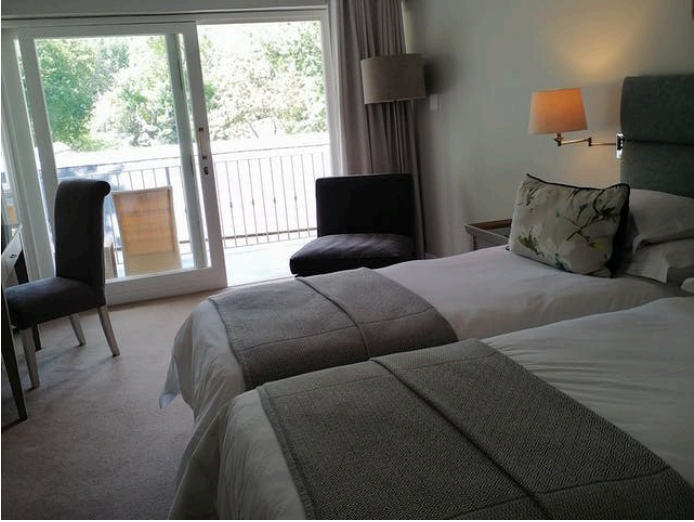
Valley Suites >> Room 31 > No Asbestos

| Material | No Asbestos Identified | Extent | |

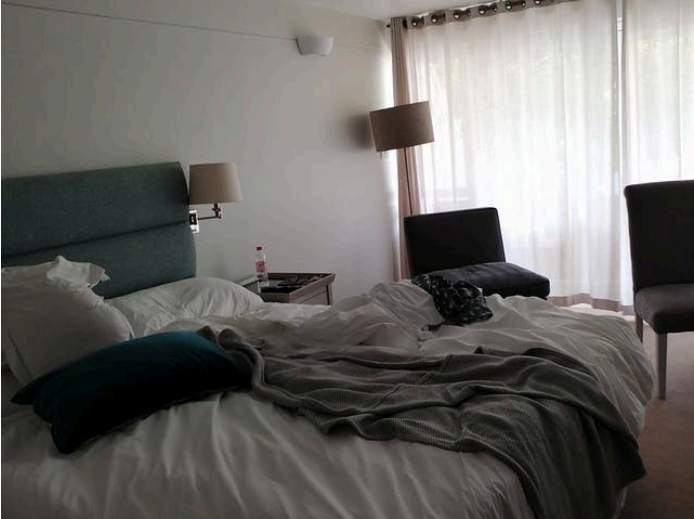
Valley Suites > > Room 32 > No Asbestos

| Material | No Asbestos Identified | Extent | |

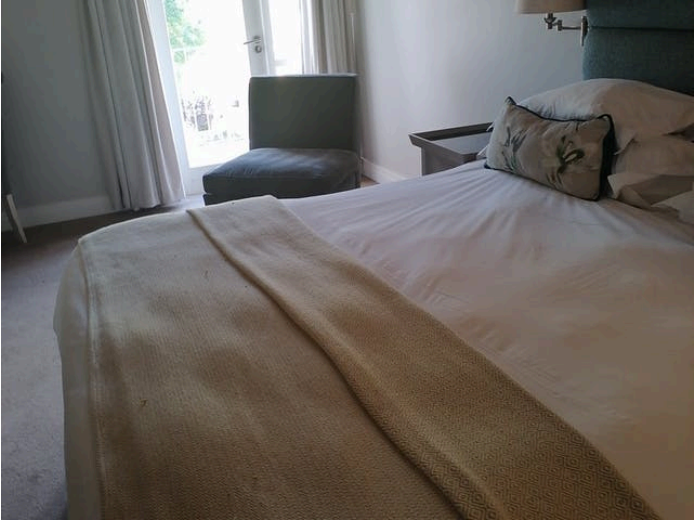
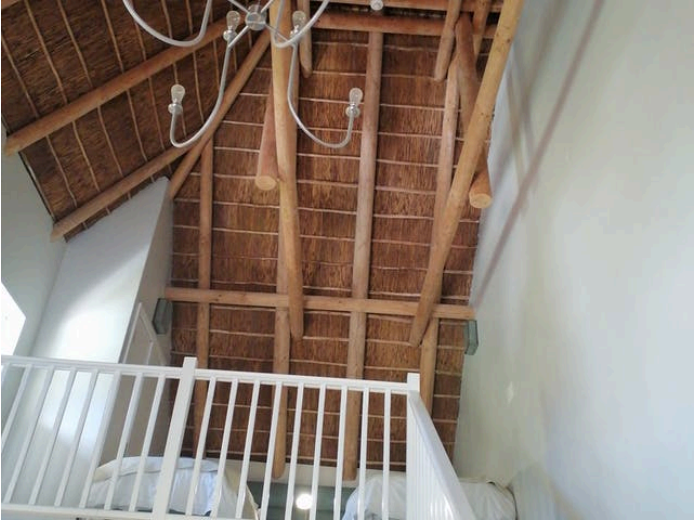
Valley Suites > > Room 34 > No Asbestos

| Material | No Asbestos Identified | Extent | |

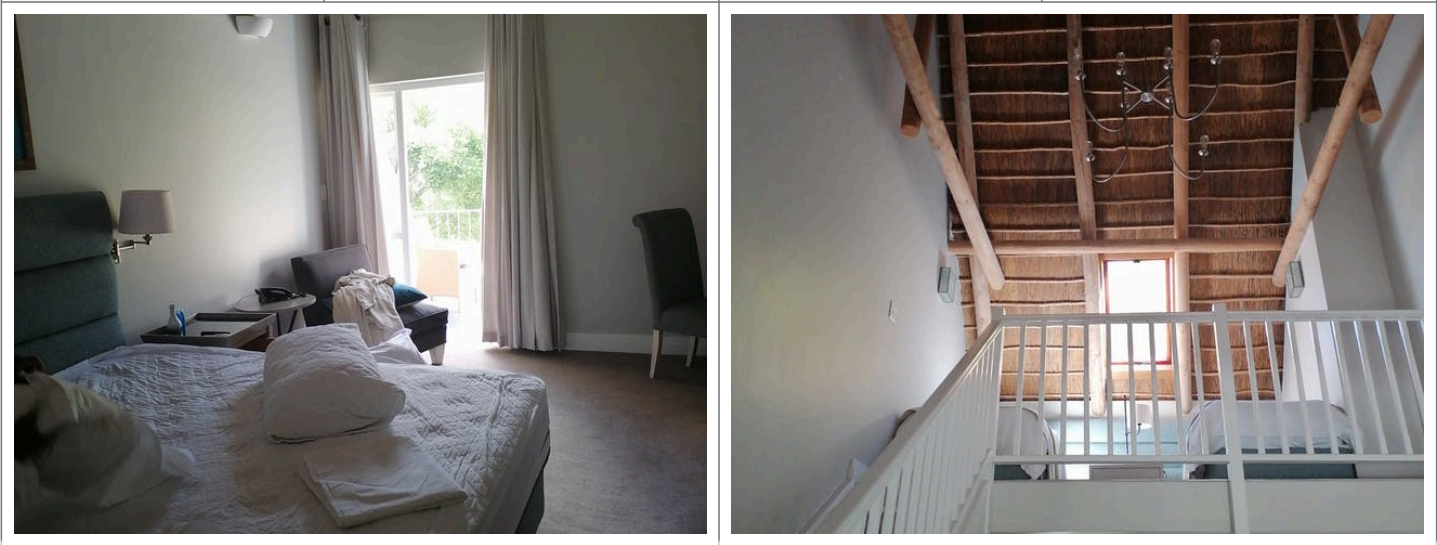
Valley Suites >> Room 35 > No Asbestos

| Material | No Asbestos Identified | Extent | |

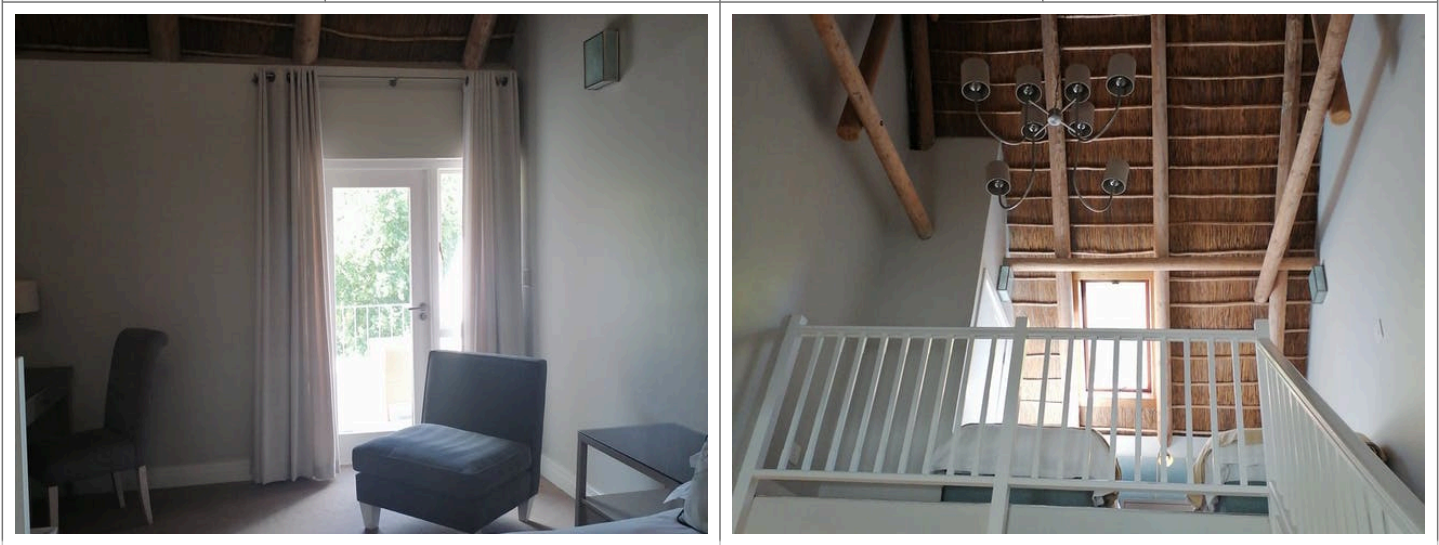
Valley Suites > > Room 36 > No Asbestos

| Material | No Asbestos Identified | Extent | |

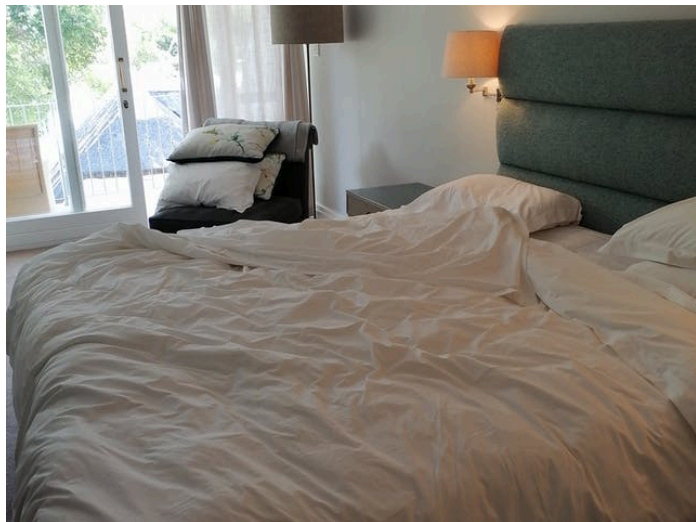
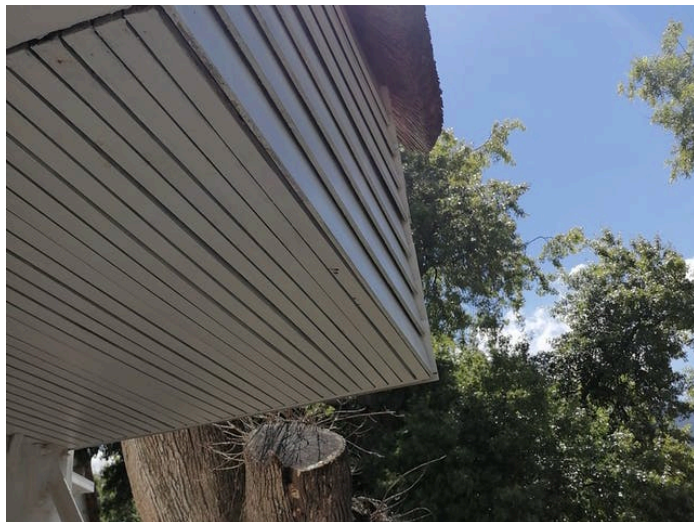
## Valley Suites > > Room 37 > No Asbestos

| Material | No Asbestos Identified | Extent | |

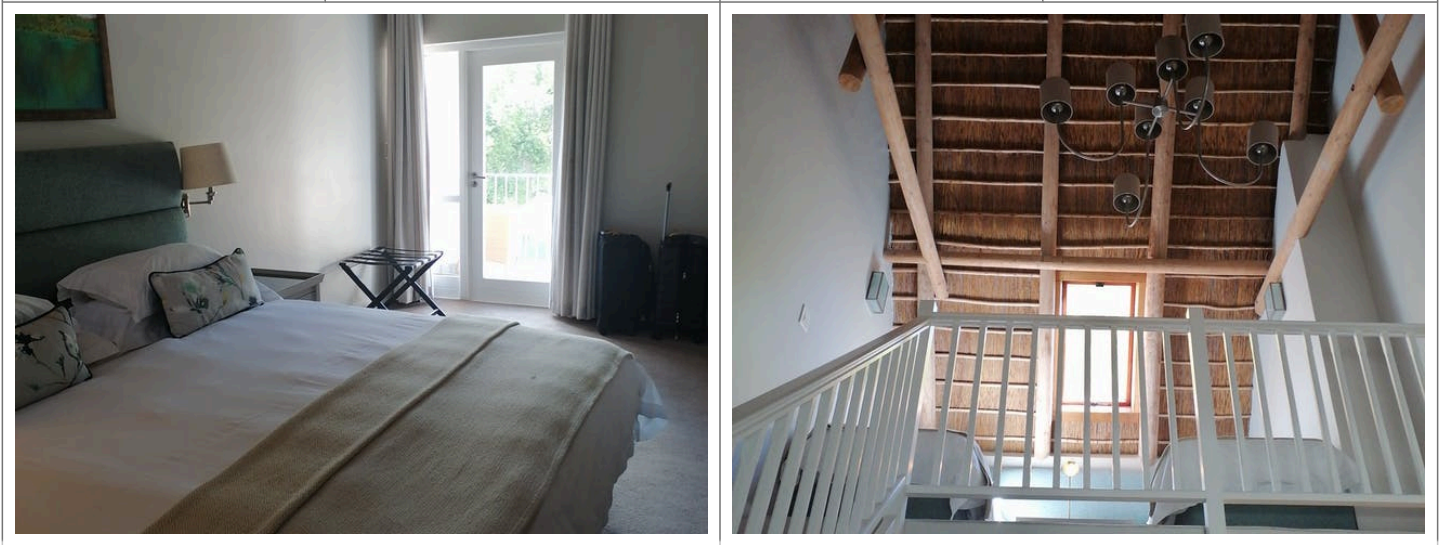
Valley Suites > > Room 38 > No Asbestos

| Material | No Asbestos Identified | Extent | |

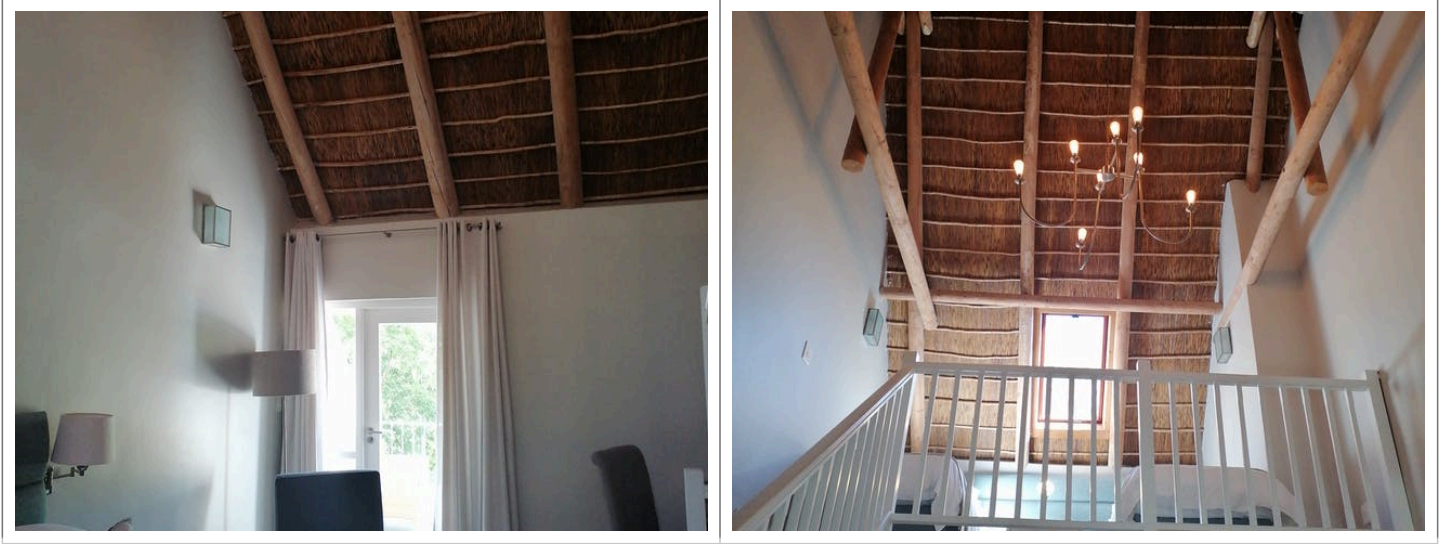
Valley Suites > > Room 39 > No Asbestos

| Material | No Asbestos Identified | Extent | |

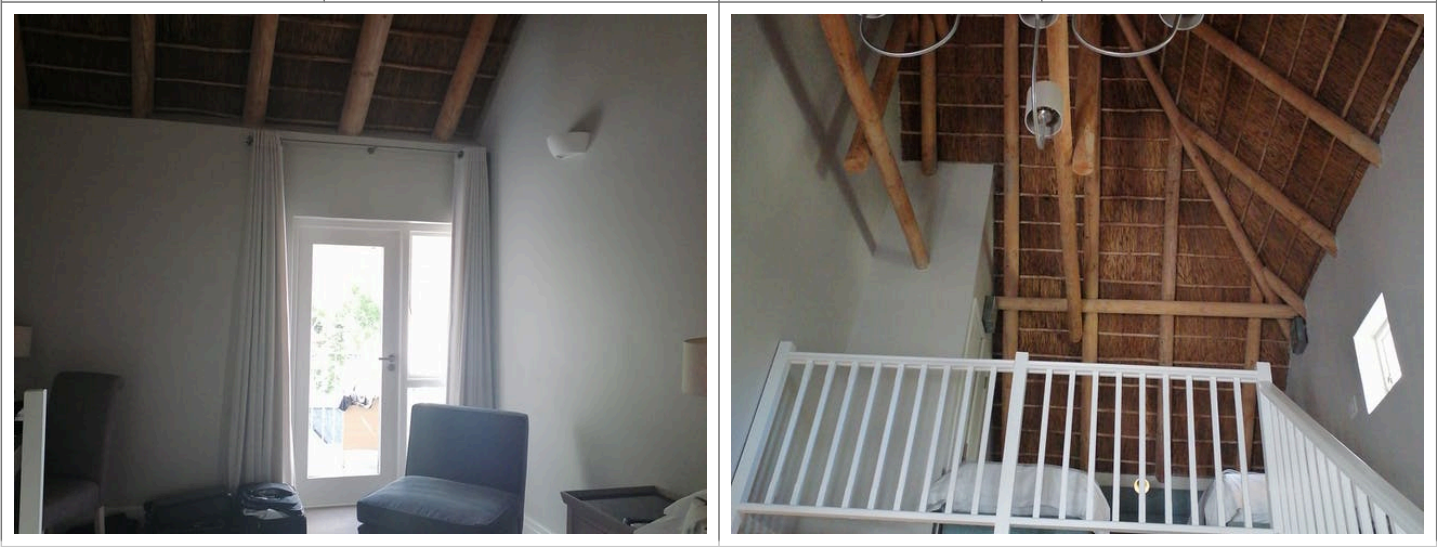
Valley Suites > > Room 40 > No Asbestos

| Material | No Asbestos Identified | Extent | |

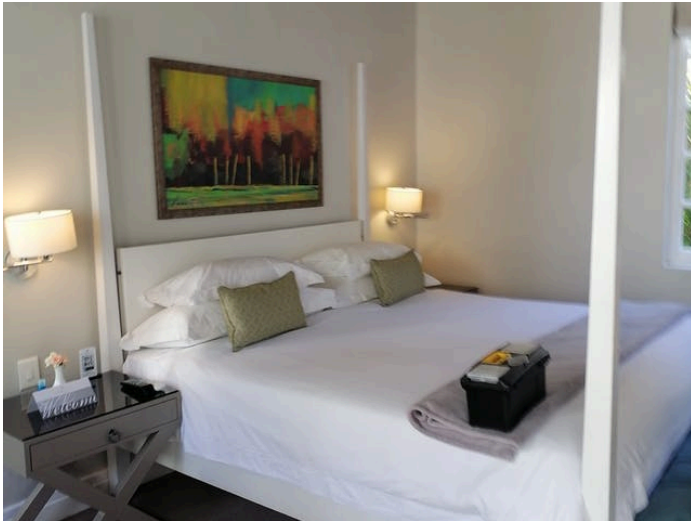
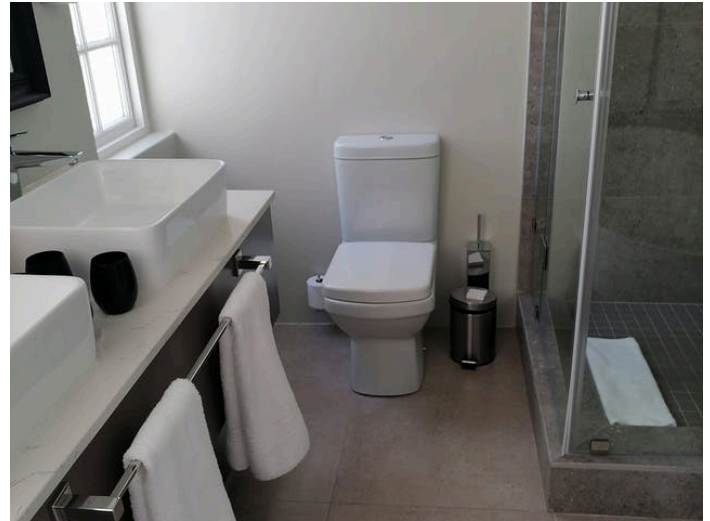
## Valley Suites > > Room 44 > No Asbestos

| Material | No Asbestos Identified | Extent | |

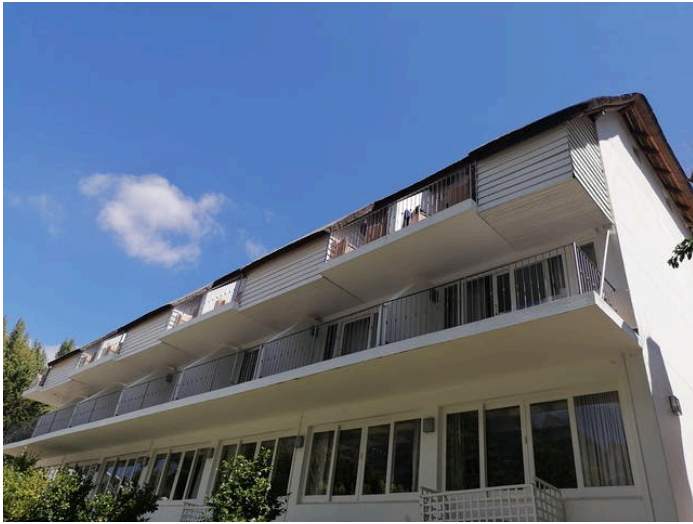
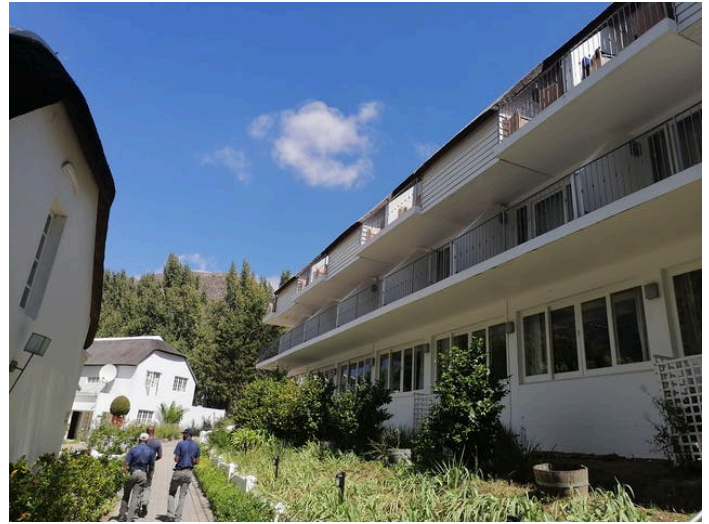
## Valley suites &gt; &gt; Side cladding &gt; No Asbestos

| Location | Side cladding | Item | No Asbestos |
| Material | No Asbestos Identified | Extent | 100m <sup>2</sup> |

| Strategy / Sample Id | Sample / 005 | Fibre Type | Chrysotile |

| Product Type (or Debris from Product) | 0 | Level of Damage / Deterioration | 1 |
| Surface Type / Treatment | 0 | Asbestos Type | 1 |
| Material Score | 3 / Very Low | | |

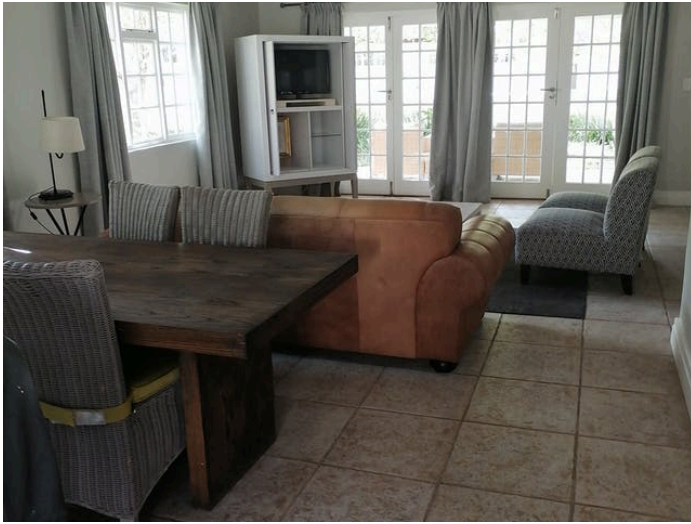
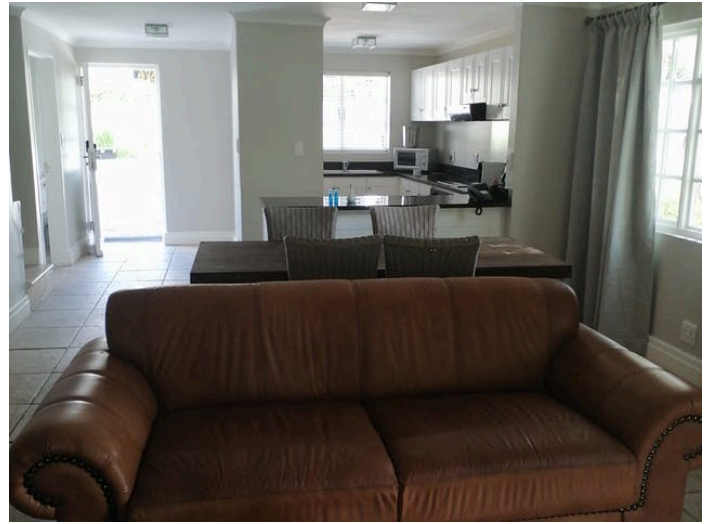
| Location | Room 71 ground floor | Item | No Asbestos |

| Material | No Asbestos Identified | Extent | |

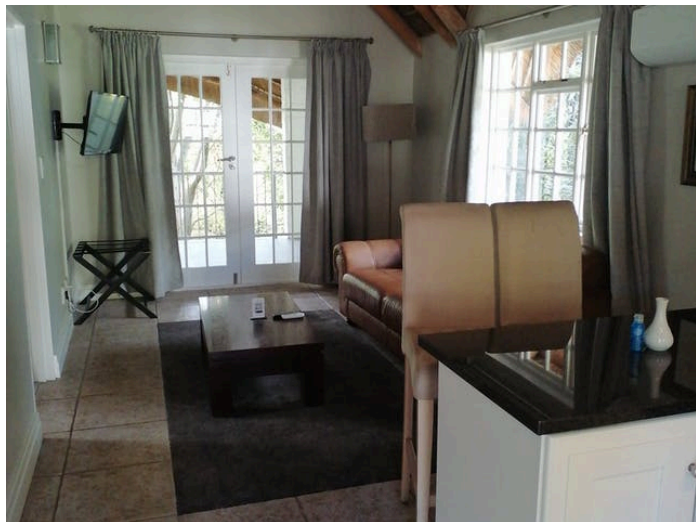
## Vineyard Suite > > Room 72 > No Asbestos

| Material | No Asbestos Identified | Extent | |

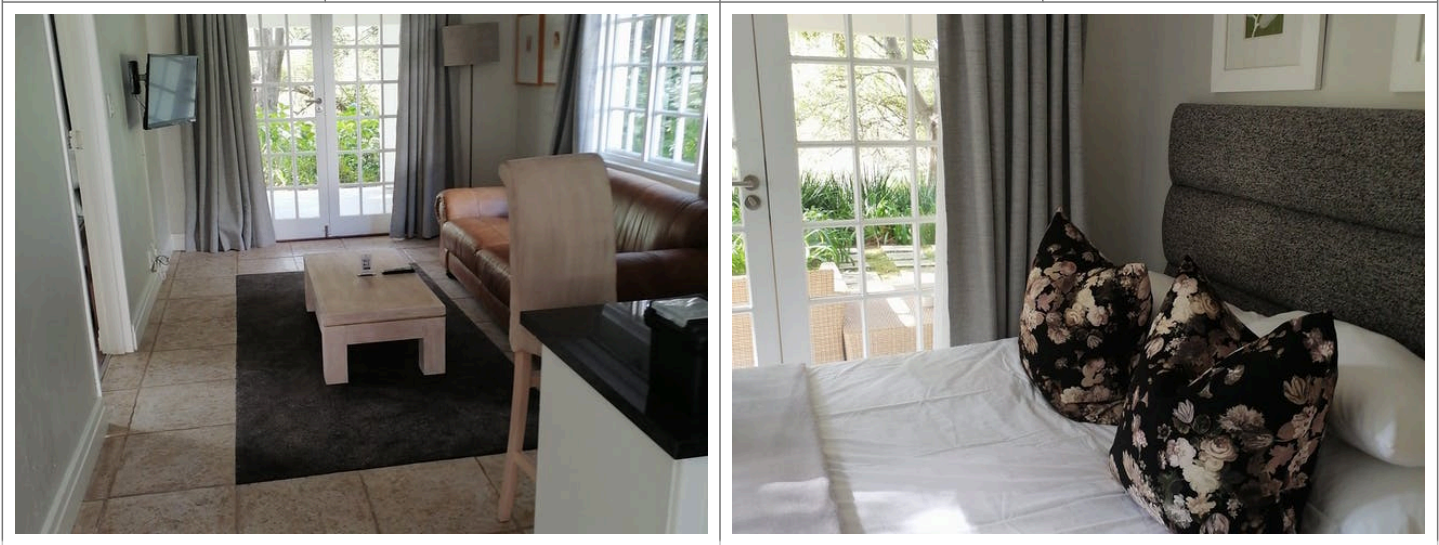
Vineyard Suite > > Room 73 > No Asbestos

| Material | No Asbestos Identified | Extent | |

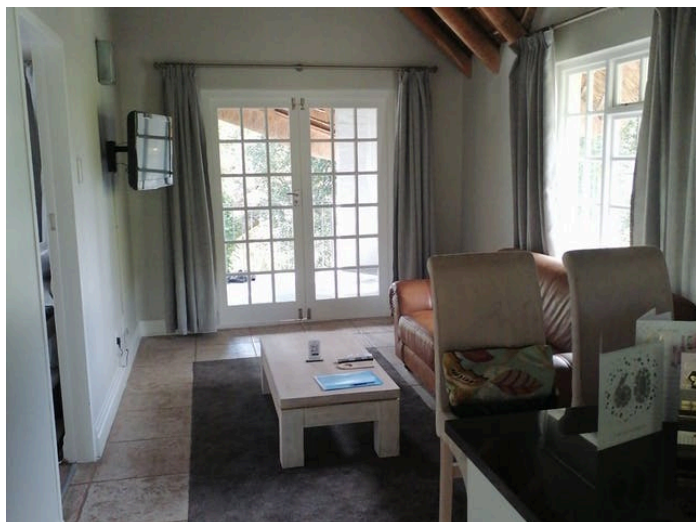
## Vineyard Suite > > Room 74 > No Asbestos

| Material | No Asbestos Identified | Extent | |
