# ASBESTOS MANAGEMENT SURVEY

16 Minor road, Franschhoek, 7690

Asbestos identification and inventory

| Client | Franschhoek Hotel & Spa |

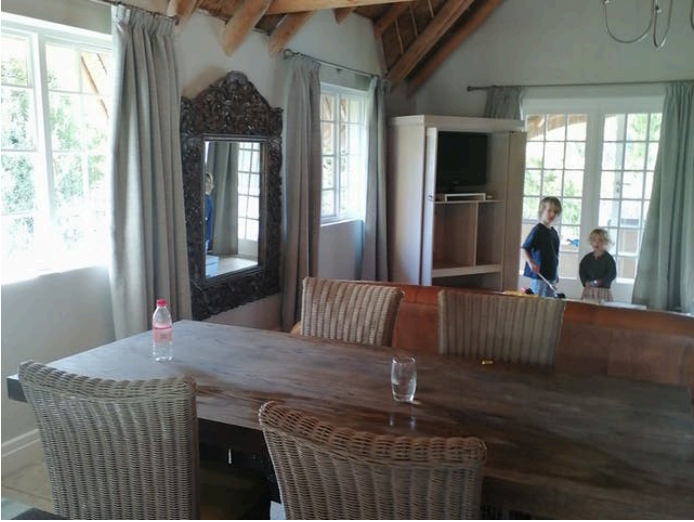
Vineyard Suite > > Room 76 > No Asbestos

| Material | No Asbestos Identified | Extent | |

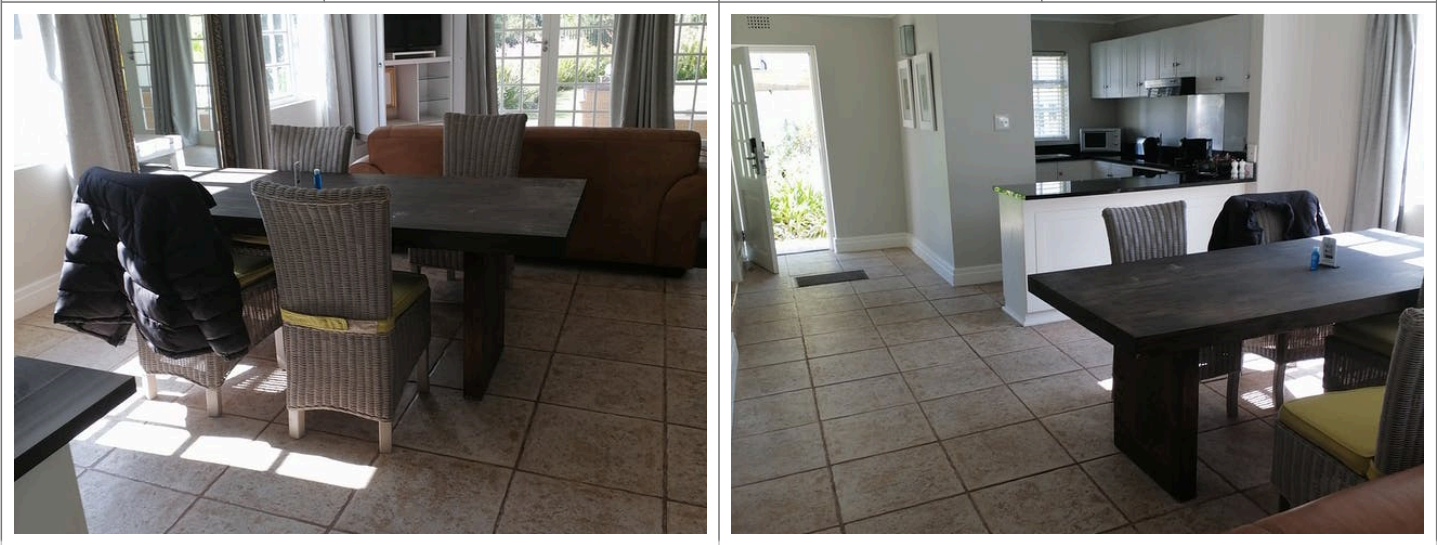
Vineyard Suite > > Room 77 ground floor > No Asbestos

| Material | No Asbestos Identified | Extent | |

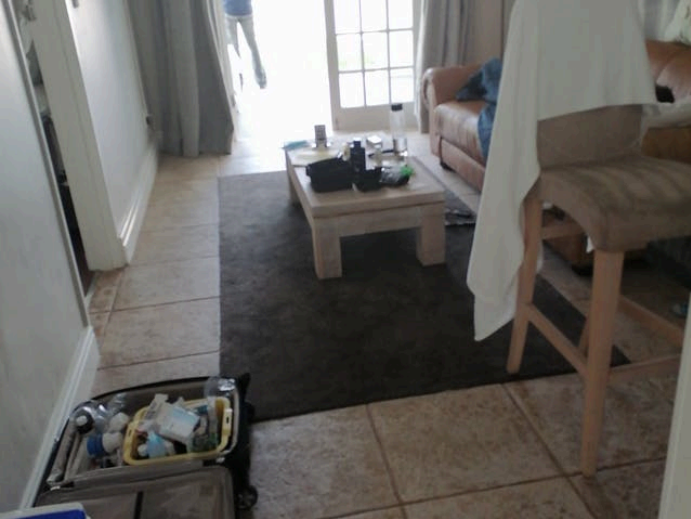
## Vineyard Suite > > Room 79 > No Asbestos

| Material | No Asbestos Identified | Extent | |

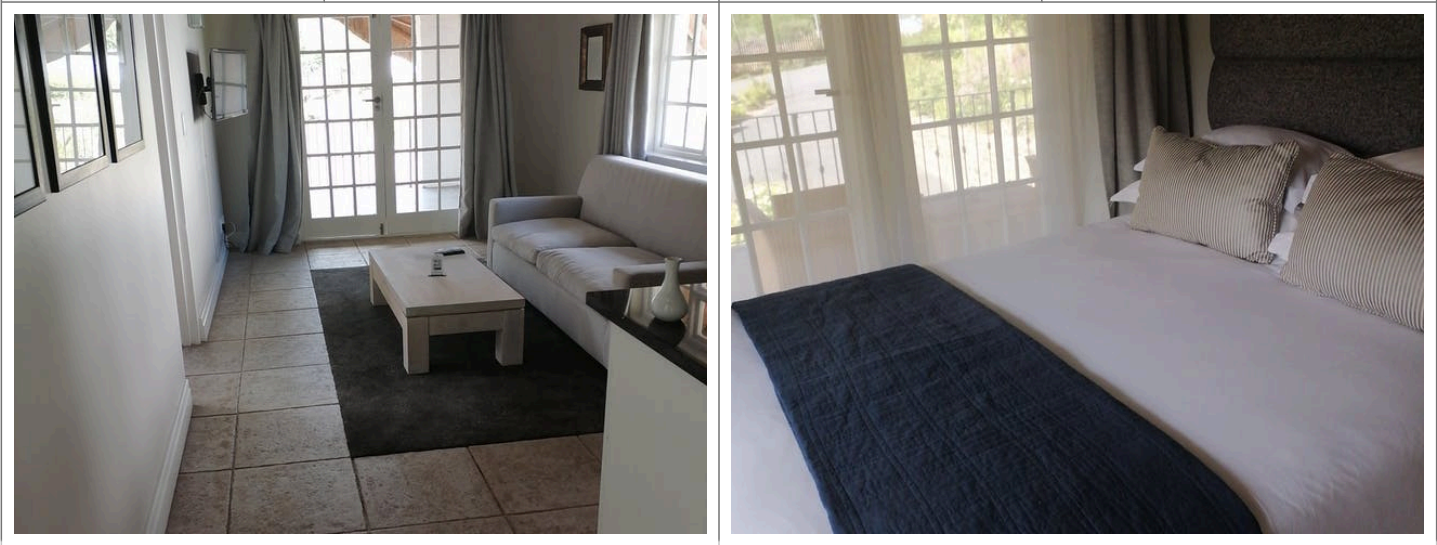
| Location | Room 78 | Item | No Asbestos |

| Material | No Asbestos Identified | Extent | |

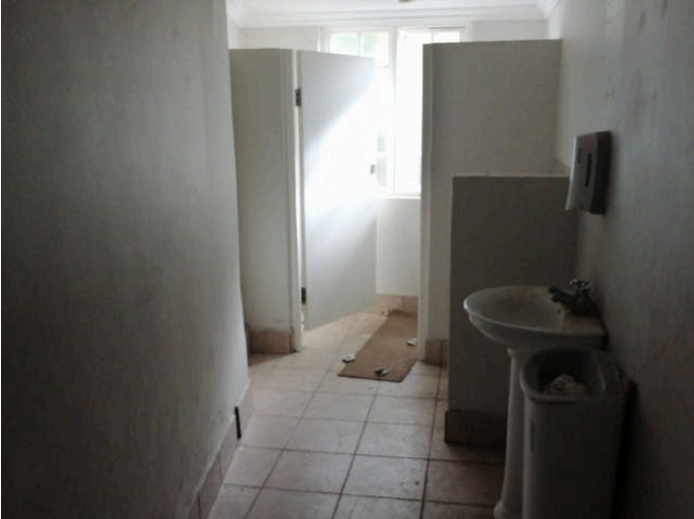
Wine House > > Bathroom > No Asbestos

| Material | No Asbestos Identified | Extent | |

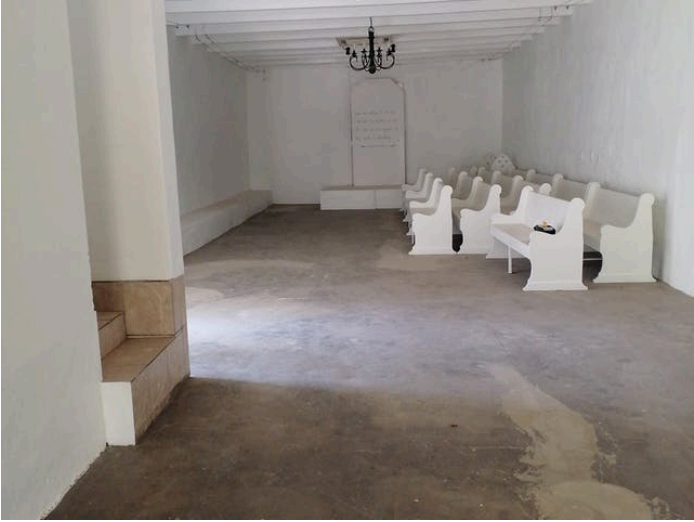
| Location | Wine House | Item | No Asbestos |

| Material | No Asbestos Identified | Extent | |
